Addendum to the May 2018 Report "Moisture Performance of High-R Wall Systems" by Home Innovation Research Labs

September 2018

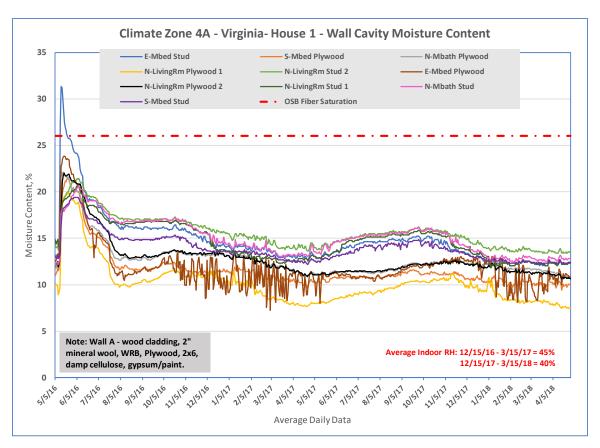
Figure A2. Plywood sheathing and stud moisture content for Climate Zone 4A, Virginia, House 1

Figure A2 shows the summary results for the wood sheathing moisture content for House 1, located in Virginia, Climate Zone 4A. The following observations can be made:

- For most of the monitoring period, the plywood moisture content was significantly less than the 26% threshold for all sensors. The initial spike in moisture content is attributed to the placement of damp cellulose in the wall cavity. The insulation installation was completed around mid-May of 2016, which is consistent with the spike in the graph. Note that the builder was operating a construction dehumidifier starting in the middle of July after the building was enclosed.

- The initial higher moisture content dissipated during the course of 45–60 days after the installation of damp cellulose, and the moisture content remained stable, ranging from 10%–156%, throughout the following three seasons remainder of the monitoring period.

- It is notable that this wall configuration did not have a winter trend of increasing moisture content as is typical for many walls in climates with heating seasons. <u>After the initial drying, moisture content</u>

<u>remained stable over the next two years.</u> Therefore, the wall was effective at controlling vapor drive from the interior during the winter with temperatures as low as 16°F in 2017 and 13°F-in 2018. The following wall characteristics help with vapor drive control: (1) R-8 exterior insulation keeps the wall cavity warmer, (2) 2x6 cavity insulation with moisture storage capacity modulates moisture load, and (3) interior paint reduces vapor movement across drywall (specific vapor-retarder properties of paint for this site are unknown).

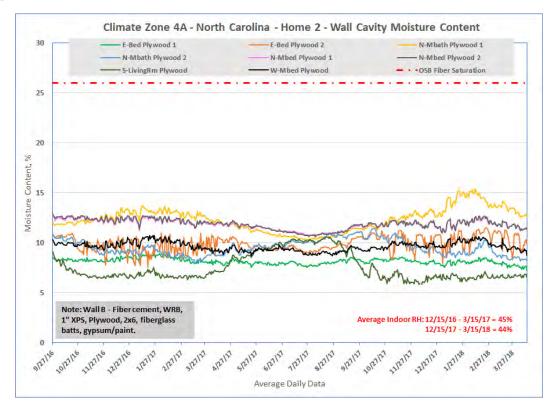
Figure A3. Plywood sheathing moisture content for Climate Zone 4A, North Carolina, House 2

Figure A3 shows the summary results for the plywood sheathing moisture content for House 2, located in North Carolina, Climate Zone 4A. The following observations can be made:

• For the whole monitoring period, the plywood moisture content was less thandid not exceed 145% for all sensors. The wall did not exhibit elevated initial moisture content, suggesting that the wall construction was complete and that the building was enclosed without subjecting materials to significant rain events.

- Throughout the entire 7<u>19</u>-month monitoring season, from September 2016 through April of 20172018, the moisture content remained stable and low. This observation is consistent with solid wood members (studs), as shown in Appendix. Therefore, this wall assembly was effective at controlling the interior vapor drive during the winter with temperatures as low as 14°F in January of 2017 and 16°F in 2018.

- Interior RH averaged <u>44-</u>45% during <u>the</u>-winter season<u>s</u>. This level of interior RH during heating season is in the upper range of levels observed in previous studies for this climate zone. An HRV was used, and it was effective at controlling the RH levels in this airtight house (1.5 ACH50).

- As typically observed in wall monitoring studies, the north-facing walls had a slightly higher moisture content (up to 135%) compared to walls facing south (as low as 76%). The following difference can be attributed to the lack of solar vapor drive in north-facing walls.

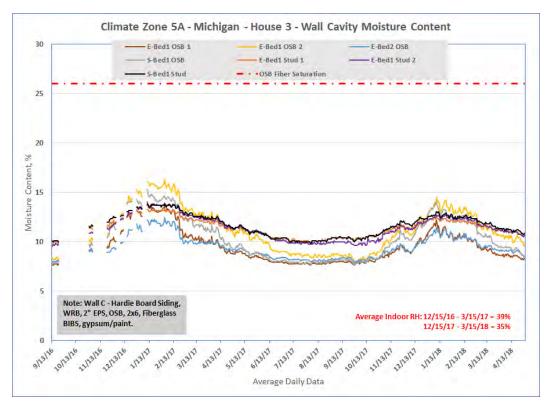
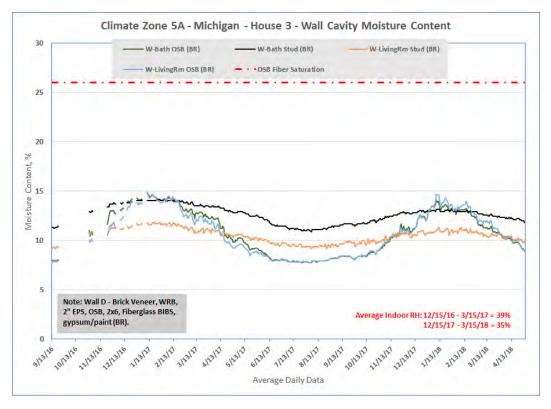
Figure A4. OSB sheathing and stud moisture content for Climate Zone 5A, Michigan (1), House 3 (Wall C)

Figure A5. OSB sheathing and stud moisture content for Climate Zone 5A, Michigan (1), House 3 (Wall D)

Figure A4 and Figure A5 shows the summary results for the OSB sheathing moisture content for Wall C and Wall D, respectively, in House 3, located in Michigan, Climate Zone 5A. Wall C and D use different claddings—fiber cement over furring strips and brick veneer, respectively; the two walls are identical in all other aspects. Data during the fall period (September–November_2017) is limited for this house because the gateway was disconnected during construction until occupants moved into the house. Although limited to only a few days, the initial data points from early readings are included to provide information on the starting moisture content levels following construction of the wall. Consistent data acquisition began in November. The following observations can be made:

- Moisture content remained low for both walls C and D throughout the <u>entire</u> monitoring period, with the highest recoded levels of 16% during the <u>first</u> winter season (outdoor temperatures as low as 10°F). <u>The second winter showed nearly identical trend with the moisture levels 1-2 percent lower. With outdoor temperatures as low as -2.8°F compared to 10°F a year before, the results suggest that the wall performance is less sensitive to the winter conditions an attribute of walls with exterior insulation.
 </u>

- Both walls experienced a mild upward trend in moisture content during the heating season. During the <u>first winter</u>, <u>Tt</u>his trend was somewhat more pronounced in walls with fiber cement siding, but the difference was not sufficient to suggest a specific pattern caused by the cladding type. Because both claddings were installed with a vented gap, the walls were expected to perform similarly. Note that Wall C was predominantly east facing and Wall D was west facing the difference in orientation is the more likely explanation for any observed difference in moisture levels During the second winter, the walls performed nearly identically.

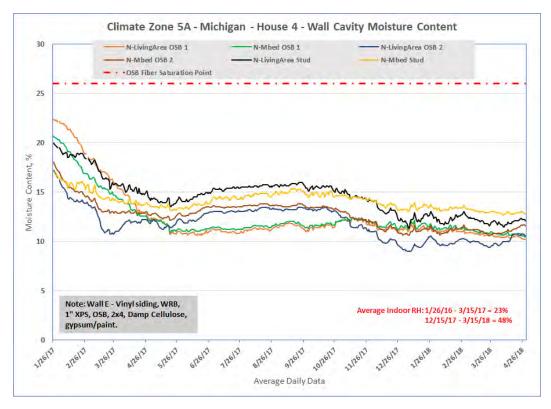
Figure A6. OSB sheathing and stud moisture content for Climate Zone 5A, Michigan (2), House 4

Figure A6 shows the summary results for the OSB sheathing moisture content for House 4, located in Michigan, Climate Zone 5A. Because of the construction schedule, the data period for House 4 starts in the middle of winter. The house has a limited number of sensors because of the limited amount of wall area available—the house is a narrow townhouse with a large area of openings. Wall E meets the minimum IRC prescriptive code provisions for Climate Zone 5A for the R-value of exterior foam sheathing for walls with a Class III interior vapor retarder (R-5 over 2x4 wall). The following observations can be made:

As expected with the placement of damp-sprayed cellulose insulation in the wall cavity, the initial moisture content of the OSB and framing ranged fromreached or exceeded 20% 25% at three sensor locations. These high moisture content levels were sustained throughout the winter, with aA drying trend starting in Aprilwas observed from the beginning of the monitoring period. The drying was most likely to the inside of the house. The low indoor RH level (23%) facilitated the drying and was added by warmer temperatures in the cavity.

- The house was not occupied during the <u>first</u> winter, and the interior RH was low, averaging 253%. A longer monitoring period is needed to better understand the long term moisture-management characteristics of the wall, particularly dDuring the seconda winter season when the house is occupied, the RH level increased to nearly 50%. This townhouse relies on exhaust fans for ventilation. A combination of occupant activities with this type of ventilation lead to levels of RH that represent the upper range for Climate Zone 5 based on observations from previous studies. A more typical average RH for Climate Zone 5 is in the 30-40% range.

- <u>The elevated interior RH level in the second winter didn't lead to an increase in OSB moisture content.</u> <u>The combination of exterior foam sheathing and cellulose cavity insulation was effective at keeping OSB</u> <u>moisture content levels at or below 15% throughout the winter. The second winter was substantially</u> <u>colder than the year before with outdoor temperatures dropping to -3.1°F.</u>

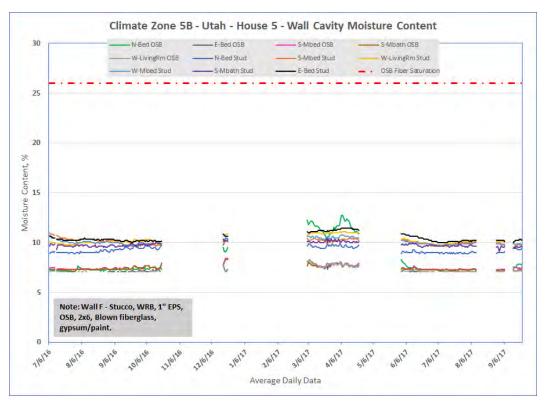
Figure A7. OSB sheathing and stud moisture content for Climate Zone 5B, Utah, House 5

Figure A7 shows the summary results for the OSB sheathing moisture content for House 5, located in Utah, Climate Zone 5B. This is the only house included in the study from an area designated as dry on the climate zone map. The cladding is one-coat stucco over 1-in. expanded polystyrene foam and an acrylic topcoat. Data for the winter period were not collected because the data acquisition system was turned off by the occupant except during 2 days at the end of December. The interior sensors were removed by the occupant. The following observations can be made:

- The initial moisture content of the OSB sheathing was low (7%) and remained low (less than 13%) based on available data during the monitoring period. The low moisture levels in the walls can be attributed to the dry climate region, summer construction, benefits of adding exterior insulation to stucco, and dry installation method for the cavity insulation (blown fiberglass). The exterior winter temperature was as low as 2°F.

- Evidence shows some winter increase in the OSB moisture content for the north orientation. The level of the increase is unknown because of the data acquisition interruption, but it appears to be small, with an onset sometime after December. Moisture content trends remained flat in all other orientations, suggesting that solar drive is an important factor for drying. It is also expected that the foam sheathing limits the entrance of solar-driven moisture from the stucco.

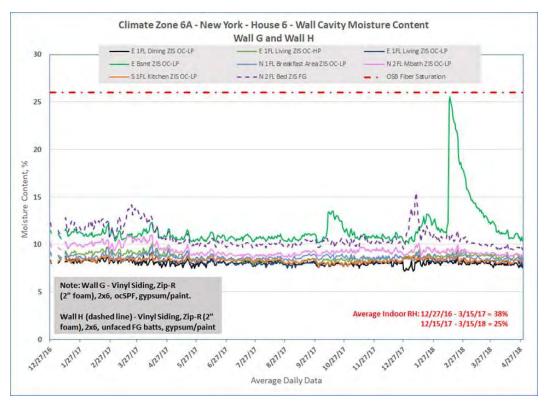
Figure A8. ZIP sheathing moisture content for Climate Zone 6A, New York (1), House 6

Figure A8 shows the summary results for the ZIP sheathing moisture content for both Wall G and H for House 6, located in New York, Climate Zone 6A. Note that two types of open-cell spray foam was used with Wall G: low-perm (LP) with specified permeance of 5 perm at total thickness and high-perm (HP) with specified permeance of 30 perm at total thickness. The type of spray foam used is noted for each sensor on the graph legend. The following observations can be made:

• The OSB moisture content was trending primarily flat at less than 145% or less for all-most sensors in all orientations with many trending below 10%. One conspicuous exception was a sensor in the walk-out basement wall that spiked precipitously during the second winter season reaching the fiber saturation level for a short period of time. Given the rate of increase, this spike was mostly likely caused by a short-

term water leak event from the outdoors. Two moderate spikes in October and January at the same sensor suggest that this location is associated with a minor breach in the water resistive barrier that gets penetrated when events reach a certain level of intensity. It's noted that this wall is below a deck and it's possible that the observed vulnerability is at the deck-to-wall joint area. It is less likely that the moisture spikes were caused by an air leak from the indoors because the uptake in moisture would have been slower and the supply of moisture would have been more persistent. The data also shows that the moisture began drying immediately after the wetting event—an indicator of the wall's capacity for dissipating moisture. While the initial rate of drying was high, it took two months for the moisture content to return to its pre-spike level. Drying in this wall can occur in both directions, but the primary drying path is expected to be to the inside.

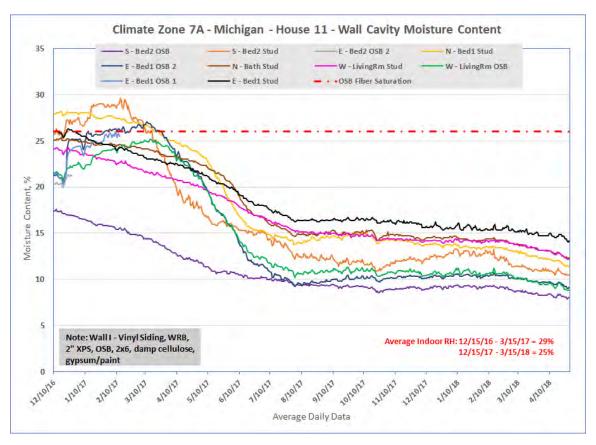
Figure A9. OSB sheathing and stud moisture content for Climate Zone 7A, Michigan (6), House 11

Figure A9_shows the summary results for the OSB and stud moisture content for House 11, located in Michigan, Climate Zone 7A. The following observations can be made:

- As a result of the construction moisture from the installation of damp cellulose, the OSB and stud moisture content remained high throughout the entire heating season. A definitive drying trend for all sensors began in March, with the OSB drying at a faster rate than the lumber. Several sensors remained at levels more than 20% at the end of April.

- <u>All sensors dropped to below 20% by middle of June of 2017</u>. Drying was complete by the end of July of 2017 as evidenced by the inflexion points on the moisture content chart for both OSB and lumber.

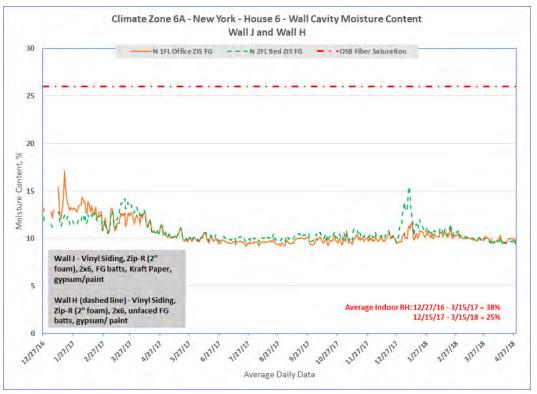
Figure A10. ZIP sheathing moisture content for Climate Zone 6A, New York (1), House 6

Figure A10 shows the summary results for the OSB moisture content for House 6, located in New York, Climate Zone 6A. Note that House 6 has three different wall types: G, H, and J. Walls G and H are addressed in Key Research Area 1 (See Figure A8). Figure A10_shows walls J and H. Wall J is classified as a hybrid wall because it uses Kraft paper as an interior vapor retarder. Wall H is shown for comparative purposes: it is identical to Wall J, but it does not have Kraft paper. The following observations can be made:

- The two wall types—with and without Kraft paper—trended closely together throughout the monitoring period. Both walls indicated good and stable performance with moisture content at less than 15% after initial drying and at about 10 percent for most of the monitoring period. Given that the sensors measured in wall sections at two different elevations in the building, the observed spread of measurements between the two walls types cannot be attributed to any specific wall characteristics. The more meaningful observation is that when both walls had a chance to start drying in April of 2017, the moisture content readings effectively converged around 10%. The performance of Wall J suggests that Kraft paper did not impede drying when the vapor drive reversed after the heating season was over.

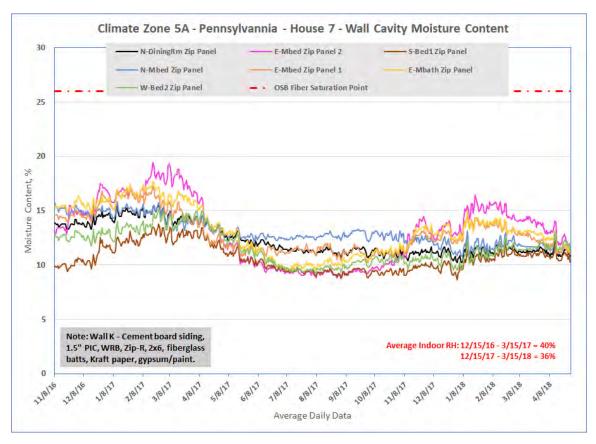
Figure A11. ZIP sheathing moisture content for Climate Zone 5A, Pennsylvania, House 7

Figure A11 shows the summary results for the ZIP sheathing OSB moisture content for House 7, located in Pennsylvania, Climate Zone 5A. The following observations can be made:

- The moisture content of the OSB sheathing was trending slightly upward throughout the <u>first</u> winter peaking, at about 19%, a reasonable margin from the fiber saturation point.

- Drying began around mid-March, with all sensors converging at less than 13% by the end of April, indicating good drying capacity.
- <u>Moisture content remained flat and stable throughout the summer at below 13%</u>. The second winter uptick was lower in amplitude and absolute value, peaking at or below 16%. This reduction in the second winter was observed despite lower winter temperatures (15°F in 2017 and 1°F in 2018). The key difference was the starting moisture level at the beginning of the heating season.

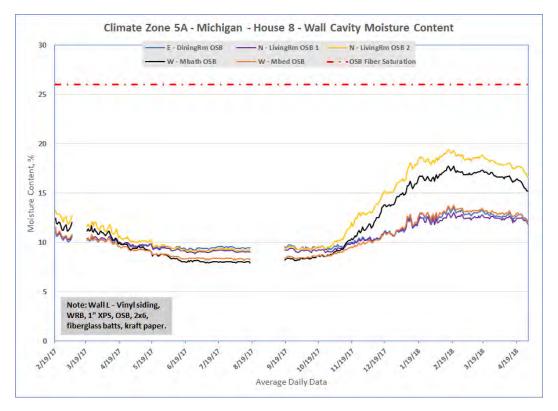
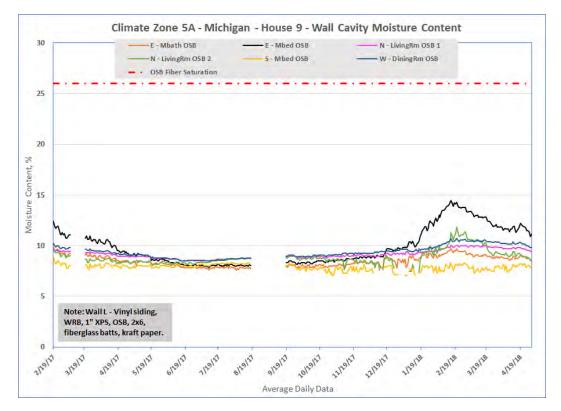
Figure A12. OSB sheathing moisture content for Climate Zone 5A, Michigan (3), House 8

Figure A13. OSB sheathing moisture content for Climate Zone 5A, Michigan (3), House 9

Figure A12 and Figure A13_show the summary results for the daily OSB sheathing moisture content for House 8 and 9, respectively, located in Michigan, Climate Zone 5A. The data are reported jointly for both houses because the wall systems are the same, the houses are located in close proximity, and the observed performances were similar. Because of changes in the construction schedule, the monitoring period for House 8 and House 9 started in the middle of winter. Both houses were unoccupied for the entire monitoring period<u>during the first winter</u>. Additional monitoring is recommended for these houses. Indoor relative humidity data for these houses was not available. The following observations can be made:

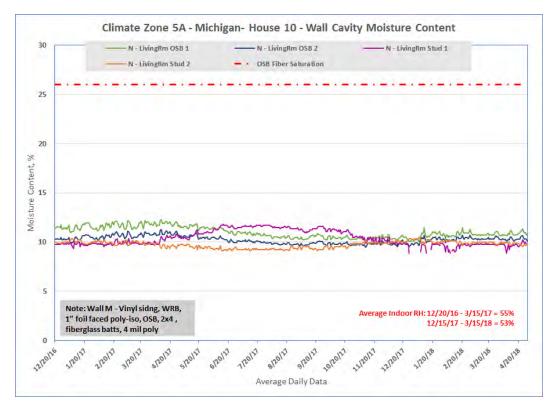
Figure A14. OSB sheathing and stud moisture content for Climate Zone 5A, Michigan (5), House 10 (Wall M)

Figure A14 shows the summary results for the daily OSB sheathing moisture content for House 10, located in Michigan, Climate Zone 5A. House 10 is an existing house with a newly constructed addition featuring energy-efficient walls. All sensors were installed in the addition. The house has an air leakage rate of 3.04 ACH as tested after completion of the addition—this level of air tightness meets the criteria for homes in the study. The following observations can be made:

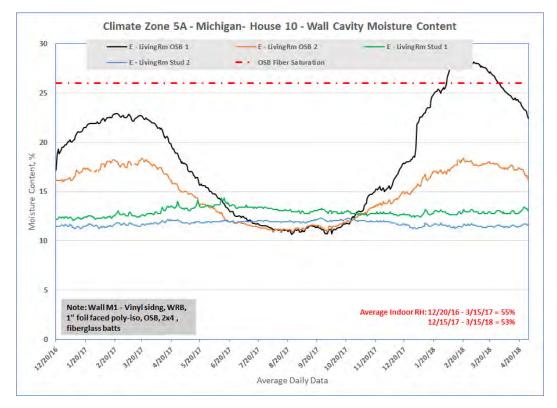
Figure A15. OSB sheathing and stud moisture content for Climate Zone 5A, Michigan (5), House 10 (Wall M1)

- A section of the wall constructed without polyethylene (Figure A15, Wall M1) showed a dramatically different performance, with moisture content levels about 10 points higher compared to wall sections with polyethylenereaching the fiber saturation point. These results suggest that even walls with an exterior insulation R-value exceeding the code minimum (R-6.5 installed vs. R-5 <u>code</u> minimum) can be sensitive to high levels of indoor RH²; The impact of the outdoor temperature was also evident: however, note that even without the polyethylenethe OSB moisture content had not reached the fiber saturation point in the first heating season (minimum temperature 18.8°F) but remained at or near fiber saturation for an extended period of time during the second heating season (minimum temperature -2.2°F). Wall M1 showed onset of drying beginning of Aprilearly spring both years.

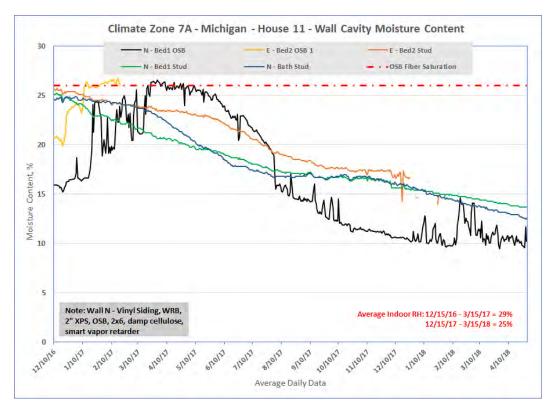
Figure <u>A</u>16. OSB sheathing and stud moisture content for Climate Zone 7A, Michigan (6), House 11

Figure <u>A</u>16 shows the summary results for the daily OSB sheathing and stud moisture content for Wall N in House 11 in Michigan, Climate Zone 7A. The wall featured a smart (i.e., variable) interior vapor retarder. The following observations can be made:

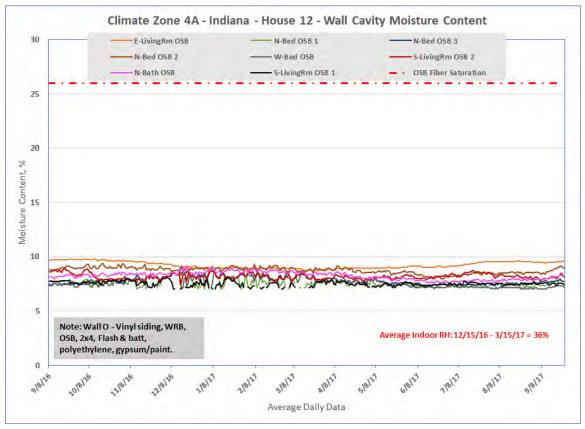
Figure <u>A</u>17. OSB sheathing moisture content for Climate Zone 4A, Indiana, House 12

Figure <u>A</u>17 shows the summary results for the daily OSB sheathing moisture content for House 12, located in Indiana, Climate Zone 4A. The following observations can be made:

- Polyethylene vapor retarder (Class I) is very effective at controlling interior vapor drive. The OSB moisture content remained stable and low (less than 10%) throughout the <u>entire</u> monitoring period. This observation is consistent with other studies and other houses in this study. (Note that walls with reservoir claddings are subject to solar drive; during the summer, this adds to moisture loads in walls with Class I vapor retarders.)
- The primary drying path for this wall system is expected to be to the outside.
- Performance of this wall assembly during <u>athe</u> cooling season <u>should be monitored to evaluatedid not</u> <u>indicate the anypotential for</u> moisture buildup in the cavity <u>because of cooler indoor temperatures</u>.

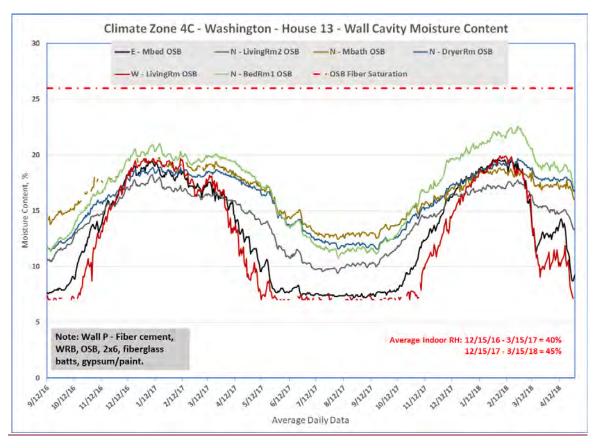
Figure <u>A</u>18. OSB sheathing moisture content for Climate Zone 4C, Washington, House 13

Figure <u>A</u>18 shows the summary results for the OSB sheathing daily moisture content for House 13, located in Washington, Climate Zone 4C. Note that because a non-vented cladding was used, the IRC requires a Class I or Class II vapor retarder (was not used in this house) in Climate Zone 4C. The following observations can be made:

- The interior RH levels during the winter seasons were 40% on average40-45%. This was somewhat lessnot far from than the results of the previous monitoring study, which showed RH levels exceeding 60%. This is one of the few sites where the second winter outdoor temperatures were a few degrees higher that the first winter (minimum temperature 25.9°F in 2016-2017 vs 29.6°F in 2017-2018).
- If a wall system with reduced seasonal fluctuations was desired, the use of a Class II interior vapor retarder (e.g., Kraft paper, membranes) should be considered. Installing cladding in a vented manner can provide another mechanism for moisture dissipation to the outdoors.

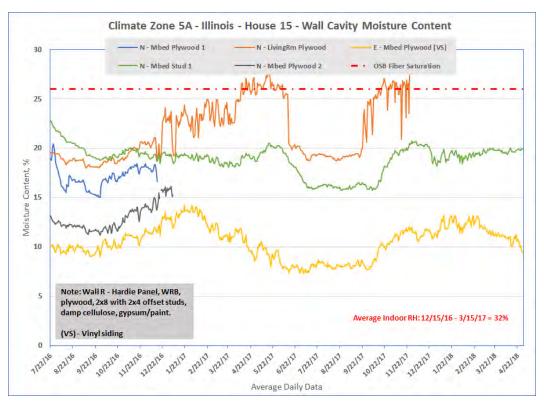
Figure <u>A</u>20. Plywood sheathing and stud moisture content for Climate Zone 5A, Illinois (1), House 15

Figure $\underline{A}20$ shows the summary results for the plywood daily moisture content for House 15, located in Illinois, Climate Zone 5A. The following observations can be made:

• Another factor that contributed to the observed rise of moisture content during the heating season was low winter temperatures at this site (as low as 1°F in the first heating season and -9°F in the second heating season).

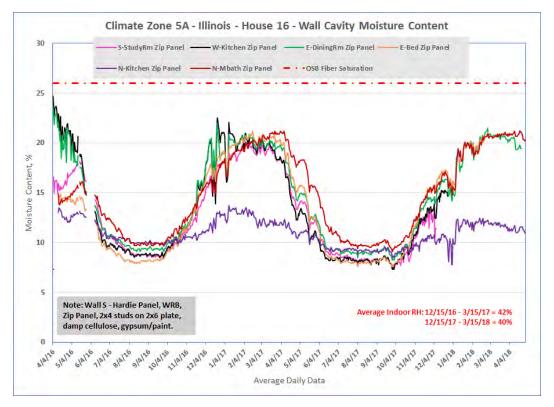
Figure <u>A</u>21. ZIP sheathing moisture content for Climate Zone 5A, Illinois (2), House 16

Figure $\underline{A}21$ shows the summary results for the ZIP sheathing daily moisture content for House 16, located in Illinois, Climate Zone 5A. The following observations can be made:

• If a wall system with reduced seasonal fluctuations is desired, use of Class II interior vapor retarders or the addition of exterior insulation should be considered.

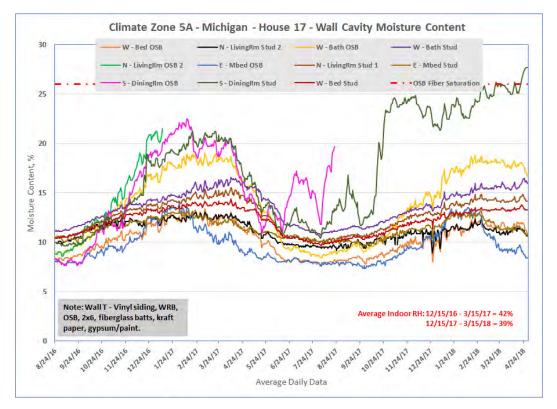
Figure <u>A22</u>. OSB and stud moisture content for Climate Zone 5A, Michigan (8), House 17

Figure <u>A</u>22 shows the summary results for the OSB sheathing and stud daily moisture content for House 17, located in Michigan, Climate Zone 5A. The following observations can be made:

- A definitive drying trend was observed in April, with moisture content rapidly dropping to levels at or near 15%. The drying path for this wall can occur to the inside and to the outside.

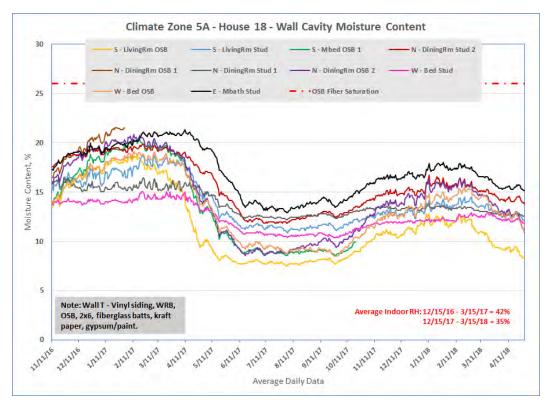
Figure A23. OSB and stud moisture content for Climate Zone 5A, Michigan (9), House 18

House 18 is similar to House 17 in construction. and pPerformance is also similar with exception of those three sensors in House 17 that showed amplified seasonal trends. The observations made for House 17 apply to House 18. The difference is that the monitoring period for House 18 began two and one-half months after House 17. In House 18, the upward amplitude during the second winter is about 4-6% lower compared to the first winter, which is likely due to the lower interior relative humidity levels.

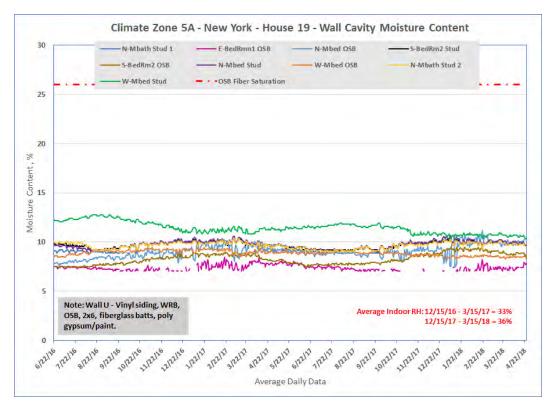
Figure A24. OSB and stud moisture content for Climate Zone 5A, New York (2), House 19

- The drying path for this wall for any incidental moisture was to the outside. The house wrap used for this house was rated at 8 perms. Although a more vapor-open house wrap may be recommended for this wall to increase its drying capacity, the observed performance did not indicate a need for a change based on the current conditions. Note that if a reservoir cladding is used, a low-perm house wrap <u>would have</u> helped control solar vapor drive.
