Characterization of
Moisture Performance
of Energy-Efficient
Light-Frame Wood
Wall Systems
– Phase II

**Forest Products Laboratory
Joint Venture Agreement
13-JV-1111136-036**

December 2015

Report No. 3352.000.12292015

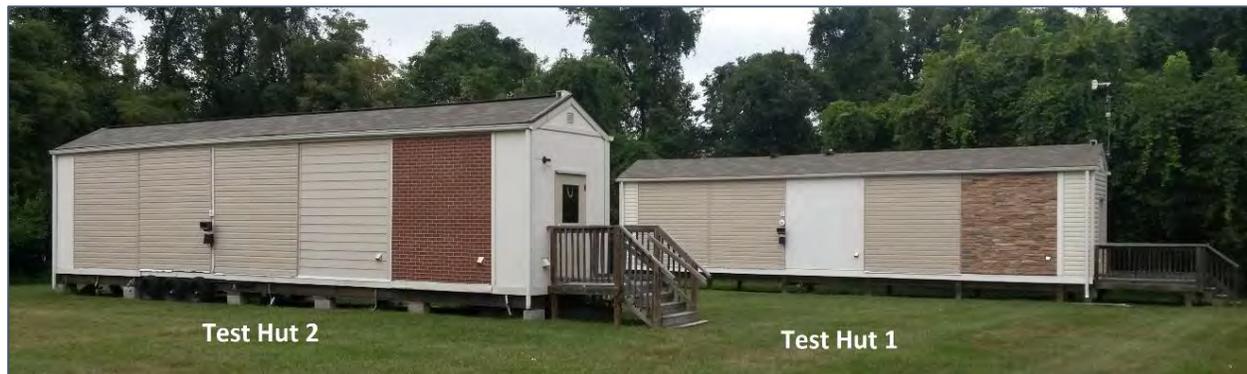
Figure 1. South Facing Walls of Test Structures 1 (right) and 2 (left)

The test structures were constructed on the grounds of Home Innovation Research Labs in Upper Marlboro, Md., approximately 20 miles east of Washington, D.C. The structures are a post-and-beam design, with a nominal footprint of 8'x48' (Figure 1). The hut design allowed for five pairs of 8'x9' wall test panels to be installed as exterior wall sections, with one panel of each pair having southern exposure and the other panel of the pair having northern exposure. The 8'x9' test panels were typically framed with 2x4 studs, sheathed with wood structural panels. The panels included various combinations of cladding, exterior insulation, and drainage strategies, which are described in the following section of this report. A window is located on the west end of the hut and an entrance door is located on the east end. Eight-foot on-center post spacing allows for insertion and removal of test specimens for subsequent testing. The huts' interiors were finished with ½-inch drywall and wall cavities were insulated with fiberglass batts. The perimeter of each wall panel was sealed to minimize extraneous air infiltration.

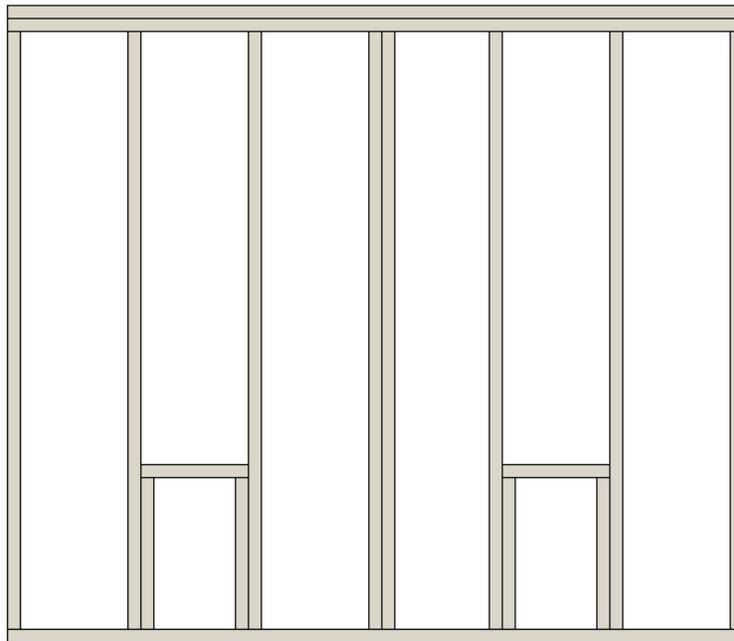
Figure 2. Typical Construction of Two Adjacent Test Wall Specimens

The nominal dimensions of the specimens are 9 feet tall by 4 feet wide. Walls were constructed with 2x4, 2x6, or a combination of both with studs spaced 16" o.c. The lumber was SPF grade 2. All specimens used fiberglass batt cavity insulation and several specimens also included R5 or R10 insulation exterior to the wall cavity and installed over or behind the OSB sheathing. A typical framing layout for two adjacent specimens is shown in Figure 2. The 4'x9' segments were framed in an identical manner containing three stud bays and the lower framing of a false window in the center bay. To simplify the construction, adjacent test specimens of identical thickness were constructed as a single 8'x9' wall with continuous top and bottom plates and a double center stud.

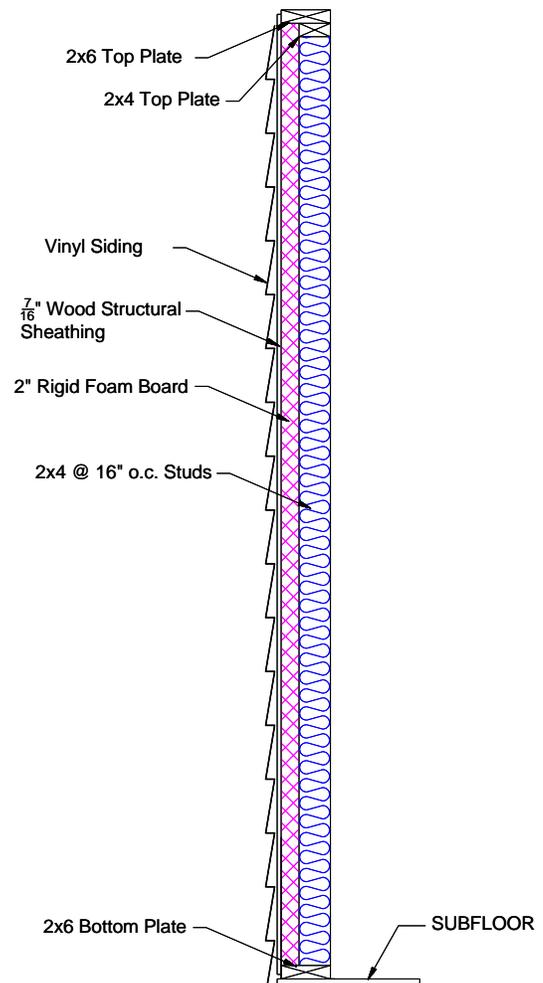
Figure 3. Extended Plate and Beam Wall Detail

- Reduced thermal shorts due to framing members
- Rigid foam insulation is set to the inside of the structural sheathing for ease of siding attachment and nailed directly to extended top and bottom plates to provide shear load resistance
- Clear drainage plane and flashing surface for window and door openings
- Cold surface exterior sheathing capable of drying to exterior and limited exposure from interior moisture diffusion
- Flexible in the selection of wall cavity and foam sheathing materials
- Flexible in the use of framing combinations for optimum overall wall thermal resistance
- In both pairs of test wall panels in Hut 2, panel 1B had air sealing using spray foam sealant between the exterior surfaces of 2x4 studs/top plate and the foam sheathing material. Panel 1A did not have spray foam sealing between the 2x4 wood members and the foam sheathing.

Because the MC sensors (by Omnisense) were installed on the interior face of the OSB, which in the case of the EP&B wall were flush with the face of the 2" XPS foam, small pockets were carved out in the foam to accommodate the sensors. The pockets were approximately 1-inch deep. To make up for the lack of insulation at the area where the sensors were located, a 1-inch thick foam block extending beyond the pocket one inch in all directions was attached to the back side of the foam board centered on the sensor locations. The 1-inch blocks were glued to the foam panel only at the block's perimeter edges such that there was no air leakage between the foam block and the foam and panel, yet there was additional vapor diffusion resistance introduced between the foam block and the foam panel.

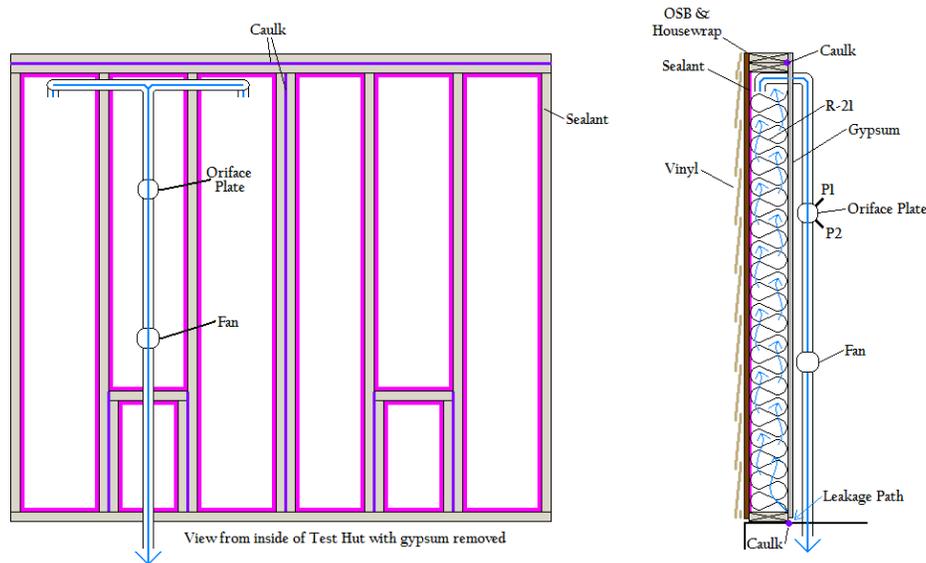
Figure 4. Controlled Air Leakage Diagram

For the specimens with controlled leakage levels (Hut 1-Walls 2B and 4B), the wall had tubes penetrating through the drywall at the top of each of the three stud bays as shown in Figure 4. Three 1/4-inch tubes were combined into a single tube exhausting the cavity air to the outside through the floor of the test hut. This tube was equipped with an orifice plate to measure air flow rate and a fan with a speed control to draw air through the wall cavity at a specific rate. The pressure drop across the orifice plate was continuously monitored in order to record the flow rate through the wall cavities at all times. Air was only allowed to enter the cavity through the unsealed bottom edge of the drywall which was gapped with a 1/32-inch shim and only allowed to exit through the tube at the top of each stud bay. Any other potential entry or exit points for air were sealed. A hole simulating a wire chase was drilled through the two interior studs to alleviate any pressure difference across the three bays. The fourth scenario (Hut 1-Wall 4A) was created similar to the controlled leakage with an air gap at bottom of the drywall and fully air sealed on the other three sides. It was not controlled mechanically.

The air flow rates were calibrated to two target house tightness levels – 3 ACH50 and 5 ACH50 for a 2,000 ft² house. The resulting air flow rates were 1 cfm or 2 cfm per 4' by 9' specimen framed with a 2x6 cavity. The total volume of exhausted air was 6 cfm (less than 1 percent of the hut volume). The intentional air flow rates remained the same as originally calibrated during the 20-month monitoring period.

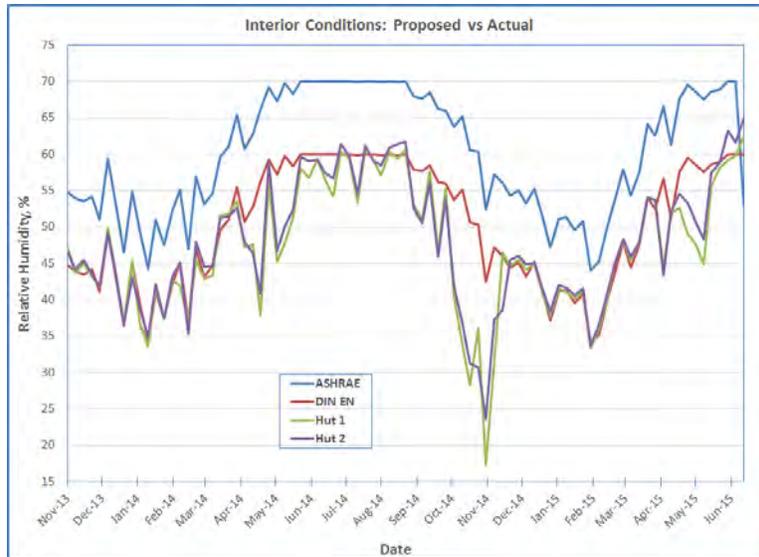
Figure 5. Test Hut Indoor Relative Humidity

Field testing continued for a total of 20 months. This duration covered two winters and all four seasons of weather exposure and a reasonable duration to monitor accumulation and drying moisture cycles of all walls on the two test huts. The indoor conditions of the test huts, both temperature and relative humidity, were controlled. The indoor relative humidity (RH) followed the European standard DIN EN 15026 normal occupancy protocol, which is lower than the indoor RH for the previous study (ANSI/ASHRAE Standard 160-2009, Home Innovation Research Labs 2013 and Glass, et al. 2015) that followed a higher moisture load curve as shown in Figure 5. The test huts were instrumented to measure MC of the OSB sheathing and wood framing, relative humidity, and temperature in each bay.

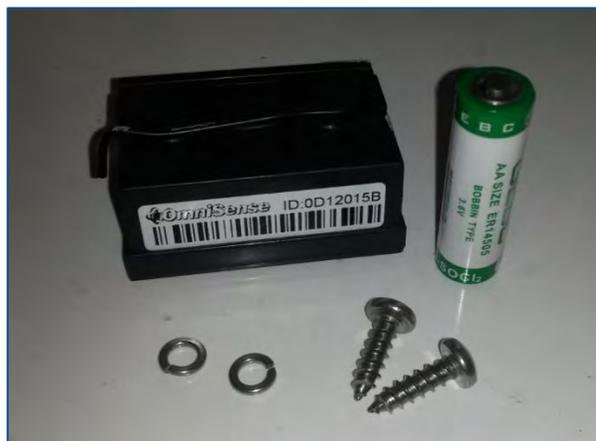
Figure 6. Wireless Temperature, Humidity and Wood Moisture Sensor

Each field wall sensor, as shown in Figure 6, includes two stainless steel screws that secure the device to either wood framing or sheathing and penetrate $\frac{3}{8}$ -inch into the substrate to obtain a conductance reading related to substrate MC. The sensors are capable of measuring MC between 7 and 40 percent, temperature between -40°F and 185°F, and relative humidity from 0 to 100 percent at programmable time intervals. Sensors were gravimetrically calibrated to the SPF studs and OSB sheathing.

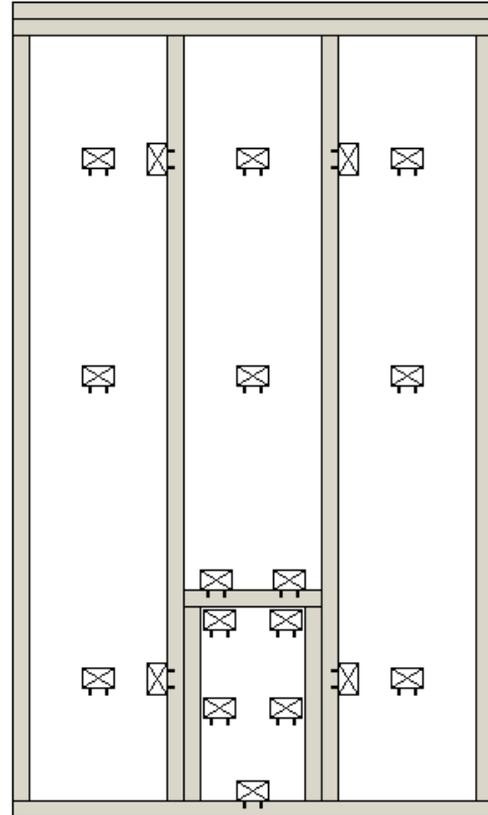
Figure 7.
Typical Sensor Locations for the Test Wall

Approximately 19 sensors (shown in Figure 7) were installed in each 4'x9' test wall panel. Data was transmitted wirelessly from the sensors to a local gateway which transmitted the data to the internet. Measurements were conducted on sufficiently short intervals (30 minutes) to allow the correlation between the MC in the wall, weather conditions monitored externally, and interior conditions. Standing fans were operating inside the hut to minimize temperature stratification.

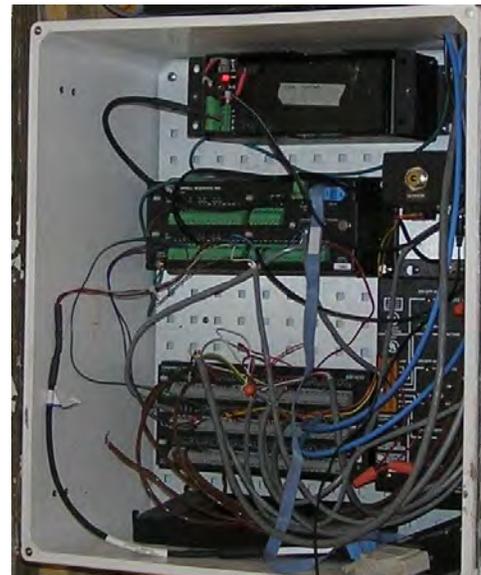
Figure 8. Data Acquisition System

In addition to the net-connected wireless sensors installed in the walls, a separate data acquisition/controller system (as shown in Figure 8) was installed in each test hut. The datalogger was programmed to take readings from indoor temperature and humidity and outdoor weather conditions every five seconds. This data was averaged or summed, as appropriate, every 30 minutes and recorded. The datalogger also had control capabilities, and was used to control indoor conditions.

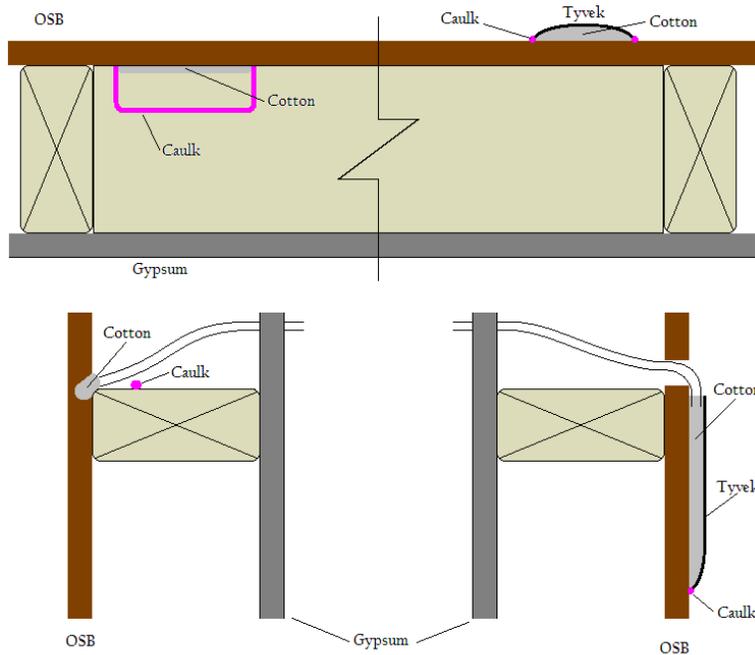
Figure 9. Setup of Wall Water Injection

For the injections on the exterior of the OSB, a pocket made of Tyvek was sealed to the exterior face of the OSB with caulk and was filled with cotton. The cotton was used to help hold the water in the injection location and expose the OSB to moisture for a greater period of time facilitating its absorption. The top of the Tyvek pocket remained unsealed so the water was able to evaporate if not absorbed by the wall. The other injection location was on the interior face of the OSB at the intersection of the window sill plate and OSB. A notch was cut in the OSB at the injection location approximately half the thickness of the OSB. It is believed that the OSB was able to absorb more water if the surface finish was disturbed. Cotton was inserted into the slit to facilitate water absorption. A bead of caulk was installed on top of the window sill plate around the slit to ensure the water was not able to flow in any direction on the window sill plate away from the slit. A diagram of these designs can be seen in Figure 9 while Figure 10 shows the tubes.

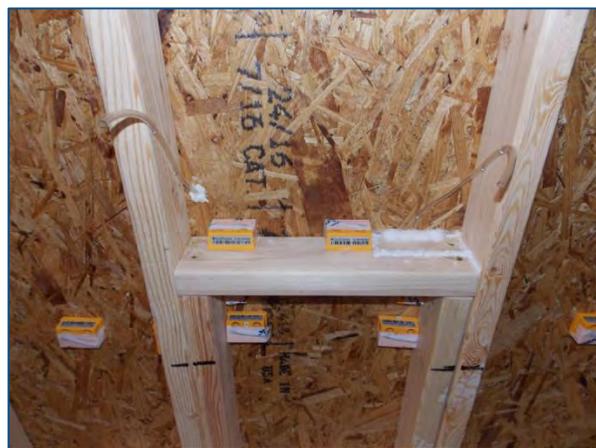
Figure 10. Water Injection Tubes in Test Walls

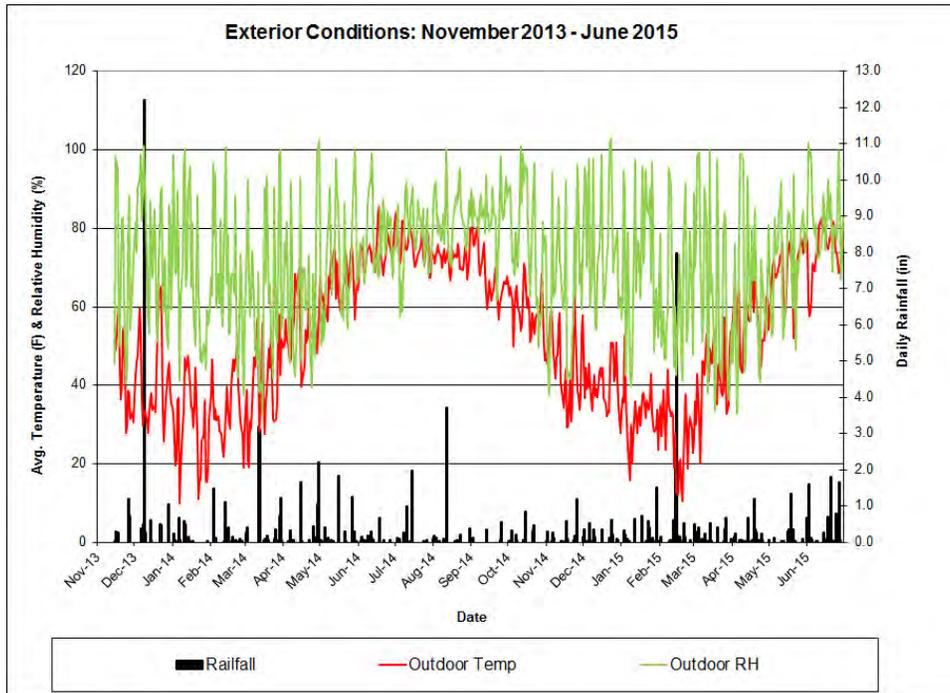
Figure 11. Measured Outdoor Conditions

Figure 11 and Figure 12 show the indoor and outdoor field test conditions for the two test huts between November 2013 and June 2015.

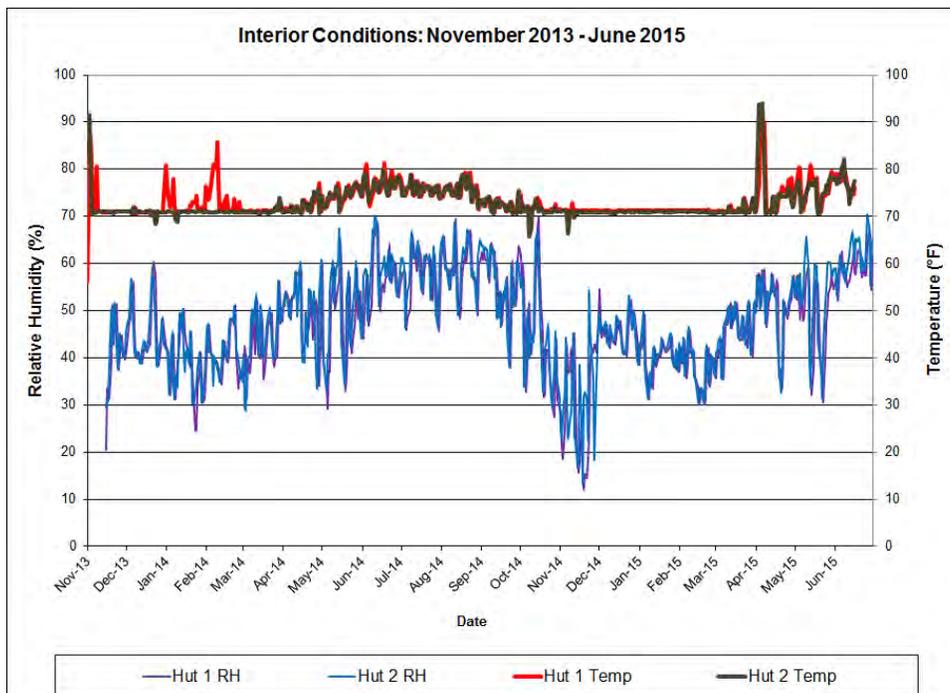
Figure 12. Measured Indoor Conditions

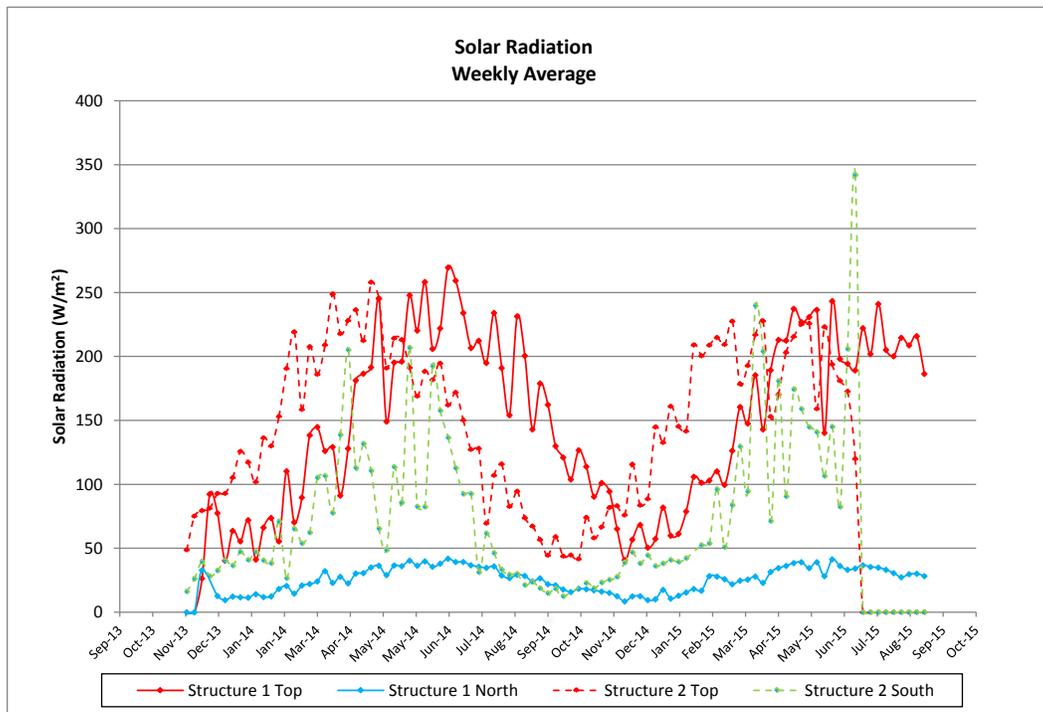
Figure 13. Measured Solar Radiation

Figure 13 depicts solar radiation data measured on a horizontal surface and in the plane of the north- and south-facing walls. The figure shows that the radiation on the south-facing surface was at a maximum in the summer. The figure also indicates the north-facing walls received only a fraction of the radiation received by the south-facing walls; the north-facing walls appeared to receive only diffuse radiation and little or no direct radiation. This information is useful when trying to understand the solar intensity on the north and south walls throughout the year. Figure 13 also shows similar solar exposure for both structures.

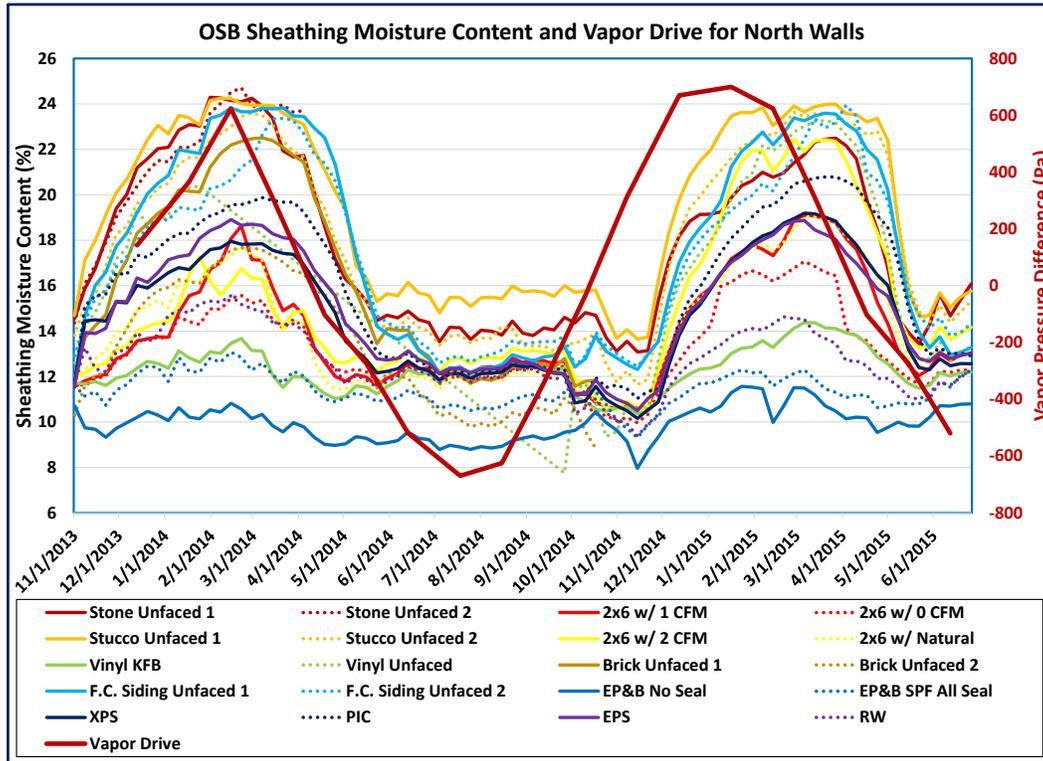
Figure 14. North Wall Sheathing Moisture Content and Vapor Drive

- A positive vapor pressure difference indicates that the net vapor pressure drive is from the inside of the building outward. The actual MC measurements followed the vapor drive reasonably closely with a time lag in year 2 (2014 – 2015) which also had higher drive than year 1.
- The sheathing of the following walls showed higher than 20 percent MC: stucco; manufactured stone; fiber cement; and brick, all with unfaced batts.

- The walls that had high MC between 18 and 25 percent in winter dried out quickly during summer to below 16 percent every year.
- Two walls showed increasing peak MC values in year 2, which are higher than 20 percent. These two walls are: 2x6 vinyl wall with 2 cfm air leakage (Hut 1 - wall 4B); and 2x4 vinyl wall with PIC exterior insulation.

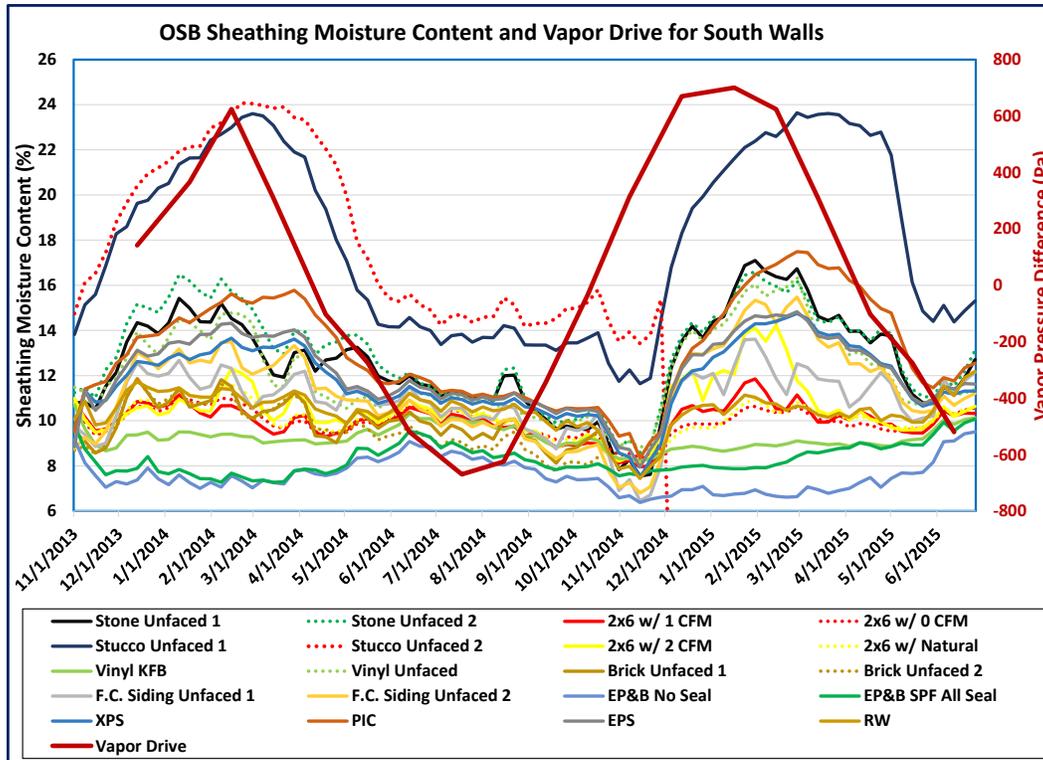
Figure 15. South Wall Sheathing Moisture Content and Vapor Drive

- Same patterns of vapor drive, MC measurements, and the relationship between them as north-facing walls.
- Sheathing MC levels for the majority of walls are much lower than their north-facing counterparts. This is due to the higher level of solar vapor drive for the southern orientation compared to the northern orientation.
- The sheathing of two walls showed higher than 20 percent MC – the two stucco walls with unfaced batts (Hut 1 - walls 3A and 3B), one of which had a malfunctioning MC sensor in the second winter. These two walls dried out quickly during summer.

- Several walls showed increasing peak MC values in year 2, which were still lower than 20 percent. This might have been caused by the more severe winter between 2014-2015.
- The sheathing of the manufactured stone walls had a significant relative difference between the winter peak on the north and south walls. They peaked at 24 percent MC on the north walls, but 17 percent on the south walls. This is attributed to the darker wall color, which made the surface absorb more solar radiation and heat on the south wall surface than the north wall surface. This consequently increased driving out of the moisture in the wall.

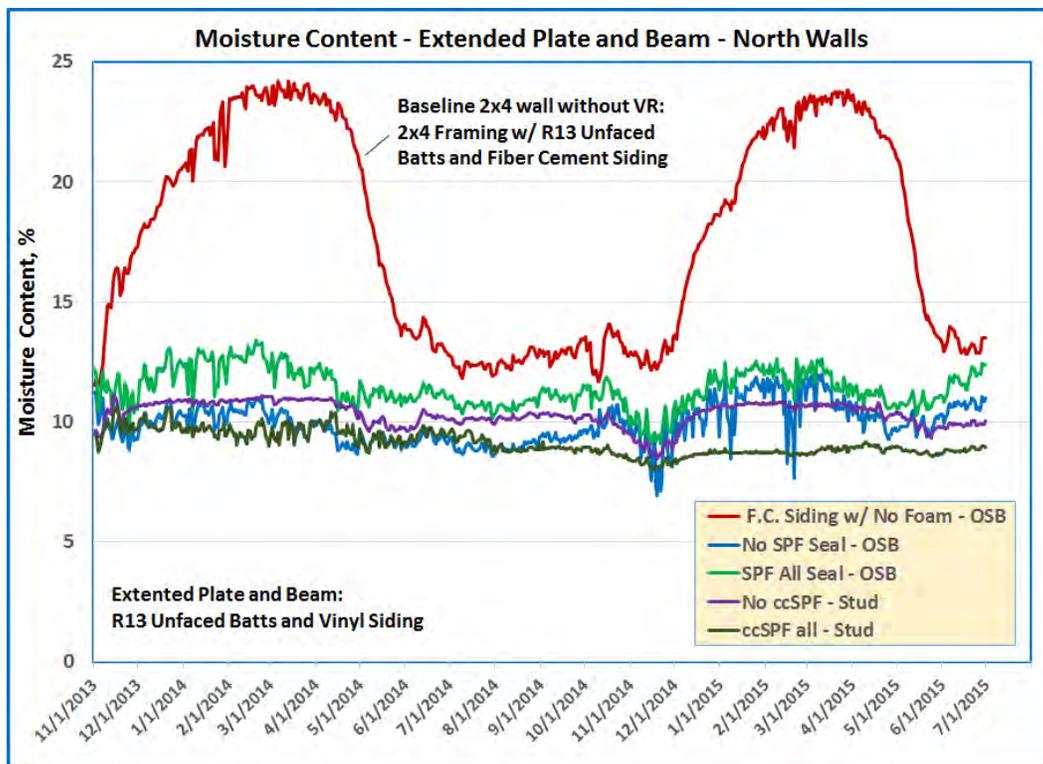
Figure 16. North Facing EP&B Wall Sheathing and Stud Moisture Content

the same hut (Hut 2), the north-facing EP&B walls showed superior moisture performance (as shown in Figure 16) including the following observations:

- The baseline fiber cement wall with unfaced batts showed winter peak MC of OSB sheathing close to 24 percent for two consecutive years. All the sheathing and stud MC measurements for both EP&B walls never exceeded 14 percent during the entire monitoring period.
- The difference of sheathing MC between the sealed and unsealed EP&B walls are approximately 2 to 3 percent indicating that the air sealing does not improve moisture performance of the EP&B walls. By design, these walls have excellent moisture performance due to the continuous foam board insulation on the interior side between the OSB and the studs.
- In the EP&B walls with unfaced batts, the studs performed well. The studs in the EP&B wall with air sealing had the best moisture performance as shown by the dark green line in Figure 16.

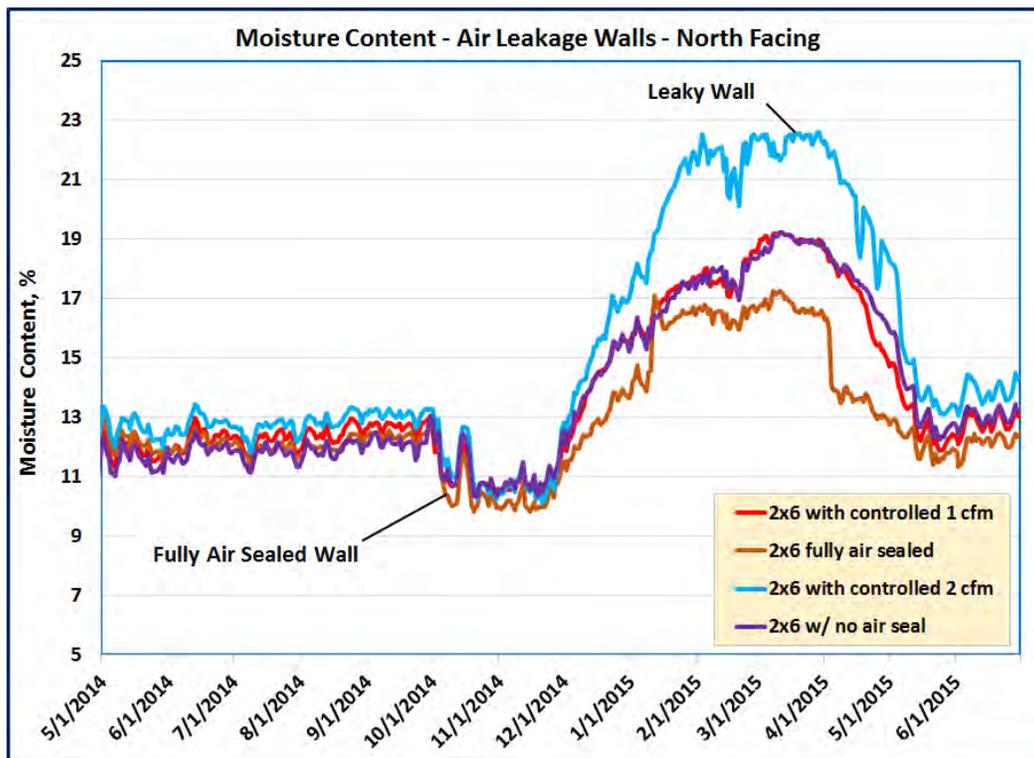
Figure 17. North-Facing Sheathing Moisture Content for Walls with and without Air Leakage

There were four 2x6 walls installed in Hut 1 for different air sealing configurations – no air seal; fully air sealed; controlled air leakage of 1 cfm; and controlled air leakage of 2 cfm. The moisture performance for these walls showed significant insight to the importance of air sealing of wood-framed walls with vinyl siding, kraft-faced batt insulation, and drywall with one coat of primer and two coats of latex paint. The following are the observations from the field monitoring data shown in Figure 17 for the north-facing walls:

- The best performing wall was the 2x6 wall that was fully air sealed. Its peak sheathing MC measurements were 16 and 17 percent for year 1 and year 2, respectively. It dried out during the summer quickly to below 13 percent.
- The leakiest wall, the wall with 2 cfm controlled air leakage, demonstrated the highest winter peak MC in sheathing – 18 percent for year 1 and increased to 22 percent in year 2. The increasing winter peak sheathing MC for 2-3 months in year 2 is a performance concern even though it can dry out quickly during the summer.
- The 1 cfm and unsealed walls performed very closely to each other and between the fully sealed wall and the leakiest wall. The winter peak sheathing MC values were 19 percent.

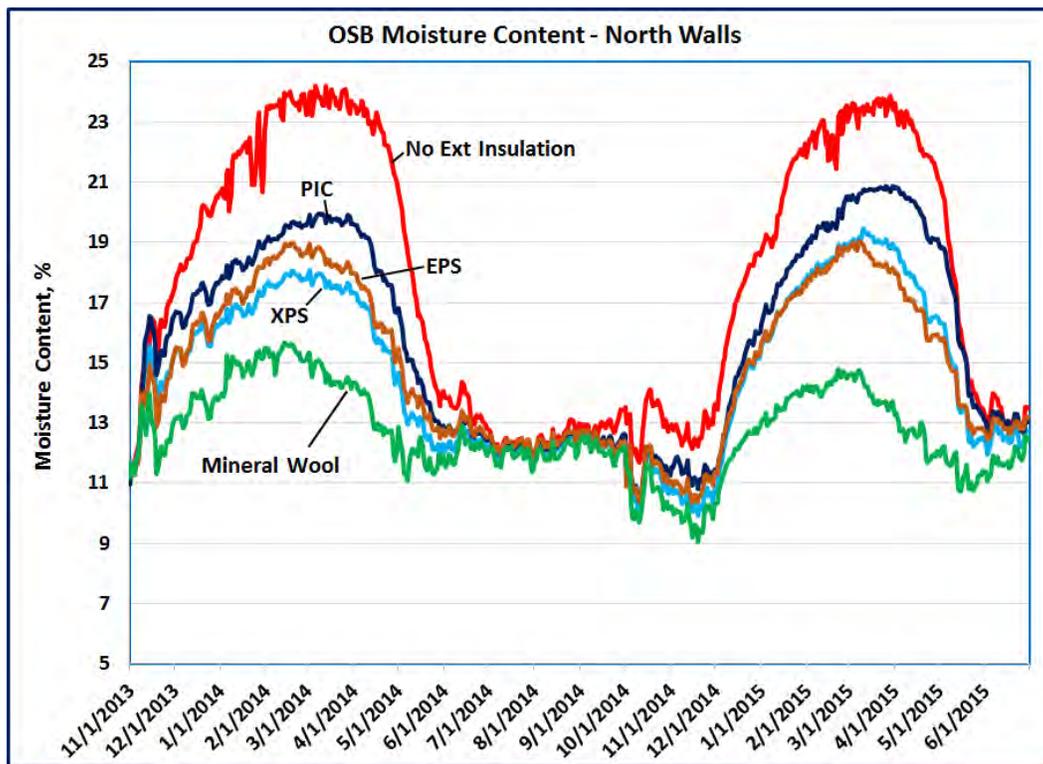
Figure 18. Sheathing Moisture Content for North-Facing Walls with Exterior Insulations

- All four walls with exterior insulation performed better than the wall with no exterior insulation, which had winter peak sheathing MC measurements close to 24 percent.

- Among the four walls with exterior insulation, the mineral wool wall performed the best. Its peak winter sheathing MC value was 16 percent for the year 1 and decreased to below 15 percent for the more severe winter in year 2.
- The wall with PIC insulation had the highest winter peak MC in sheathing – 20 percent in year 1 and increased to 21 percent in year 2. This was caused by the low vapor permeance (as shown in Table 3) of the PIC material, which reduced the drying capacity of the wall during winter when the indoor moisture was driven to and accumulated on the sheathing surface.
- The XPS and EPS walls performed very similarly. The peak winter sheathing values were between 18 and 19 percent.

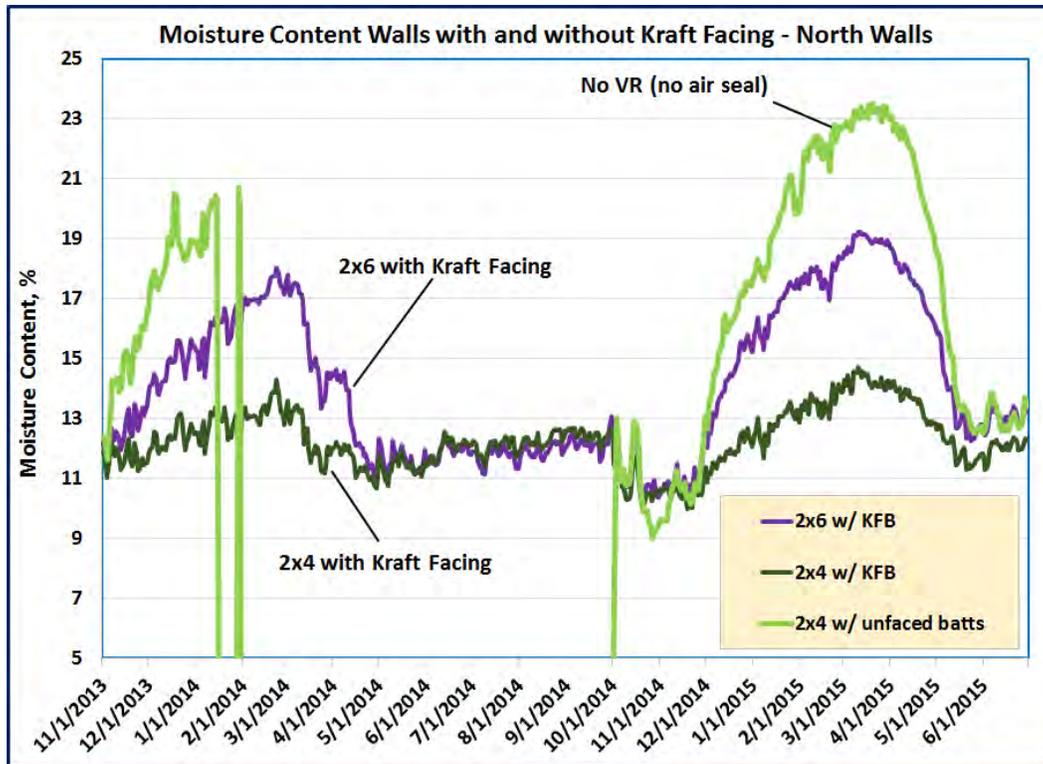
Figure 19. Sheathing Moisture Content for Walls with and without Kraft Facing with Lower Indoor Relative Humidity

The kraft facing on the insulation used in the wall cavity had significant impact on moisture performance as Figure 19 shows:

- The 2x4 vinyl wall with unfaced batt insulation performed the worst. Its peak winter sheathing MC went up to 24 percent approaching the wood fiber saturation limit of 25 percent.
- The 2x4 vinyl wall with kraft-faced batt insulation performed the best with sheathing MC never exceeding 15 percent, while the 2x6 vinyl wall with kraft-faced batts performed in between.

- All walls were able to dry out during the summer. The kraft facing on the batt insulation provided vapor resistance during the winter to prevent significant indoor moisture from transporting into the wall while allowing moisture flowing through during the summer into the conditioned space.

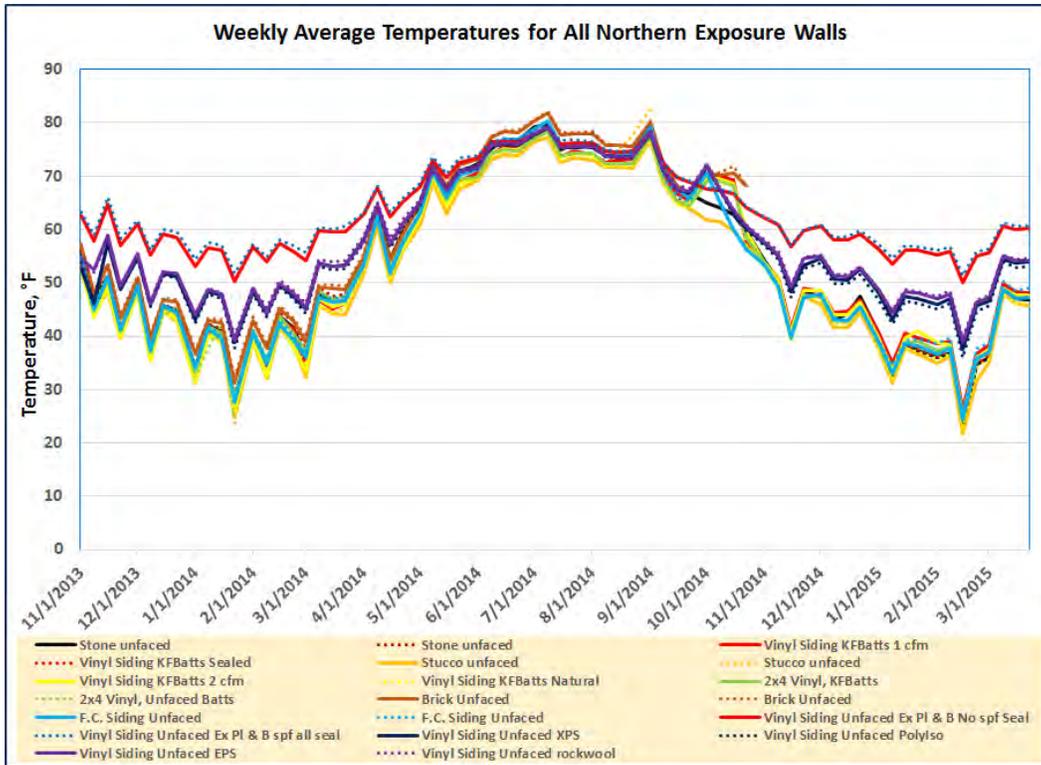
Figure 20. Weekly Average Temperature for All Northern Exposure Walls

- As expected, due to solar gains, wall cavity temperatures in south-facing walls were consistently warmer than in north-facing walls. The south-facing walls with stone and brick claddings had the highest year-round temperatures with the exception of the insulated siding in the winter months, as shown in Figure 20 and Figure 21.
- The 2x6 walls with kraft-faced batt insulation and air sealing had the highest cavity temperature in the summer and lowest in the winter, as shown in Figure 22 and Figure 23.
- In the cavity temperature charts for both northern and southern exposure walls, Figure 24 and Figure 25, the 2x4 walls with no exterior insulation showed lower winter values than those 2x4 walls with exterior insulation. The thermal resistance of the exterior insulation causes the wall cavity to remain warmer in the winter.

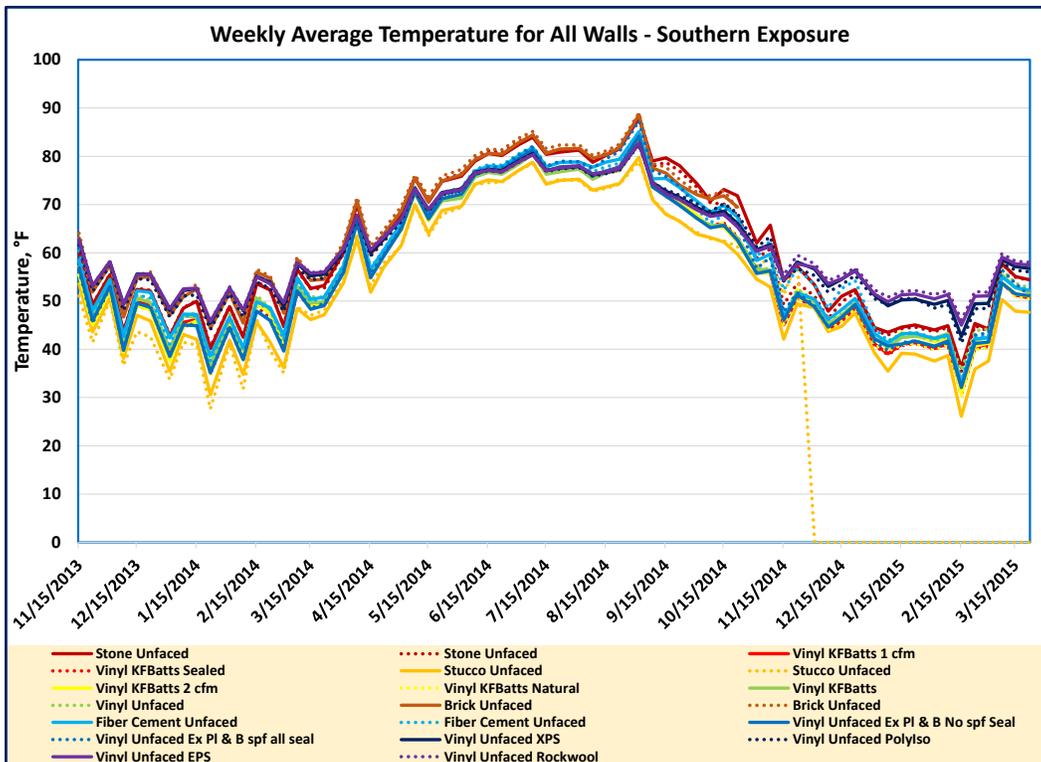
Figure 21. Weekly Average Temperature for All Southern Exposure Walls

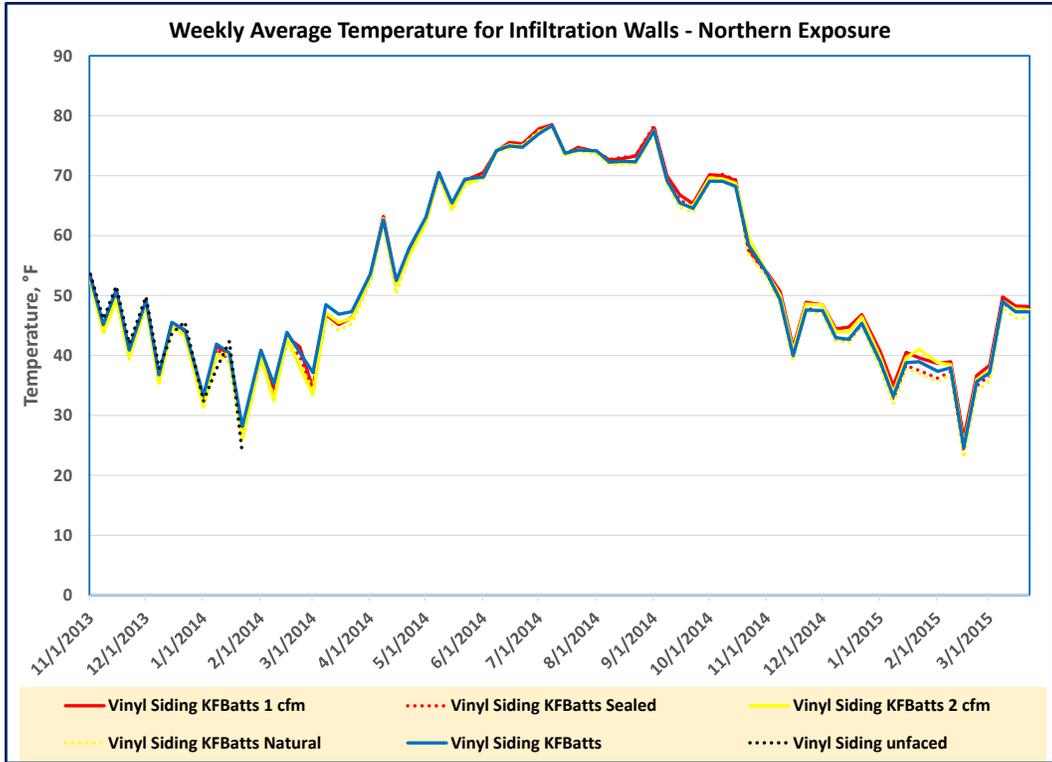
Figure 22. Weekly Average Temperature for Northern Exposure Walls with Air Leakage

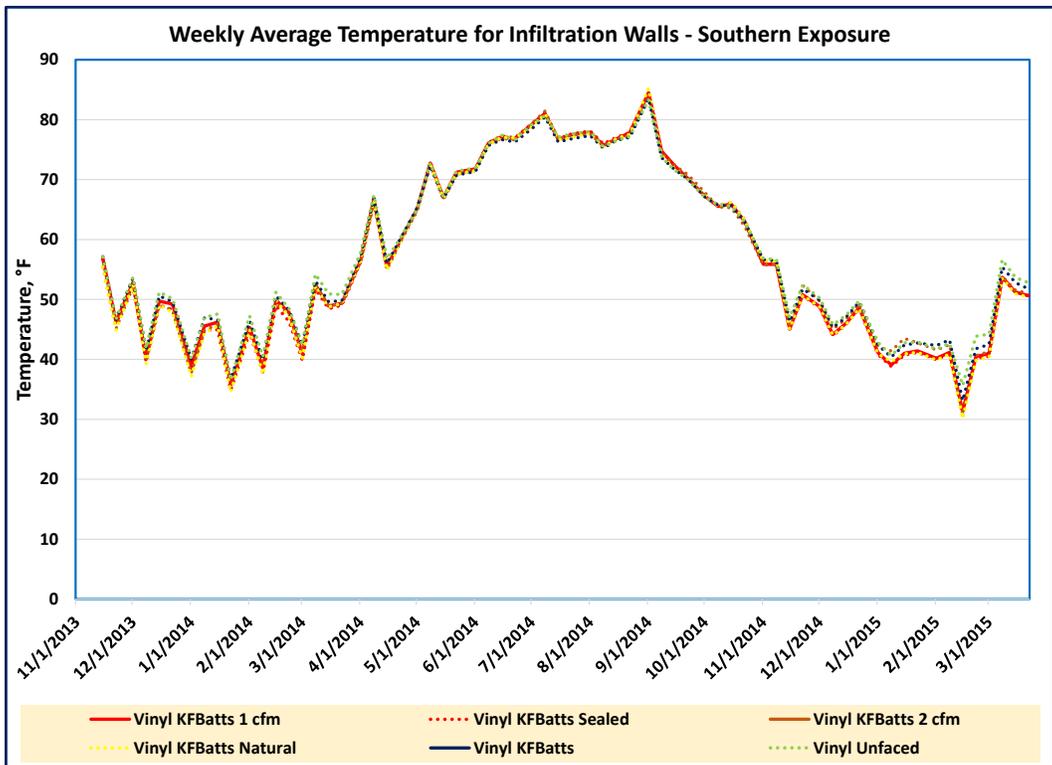
Figure 23. Weekly Average Temperature for Southern Exposure Walls with Air Leakage

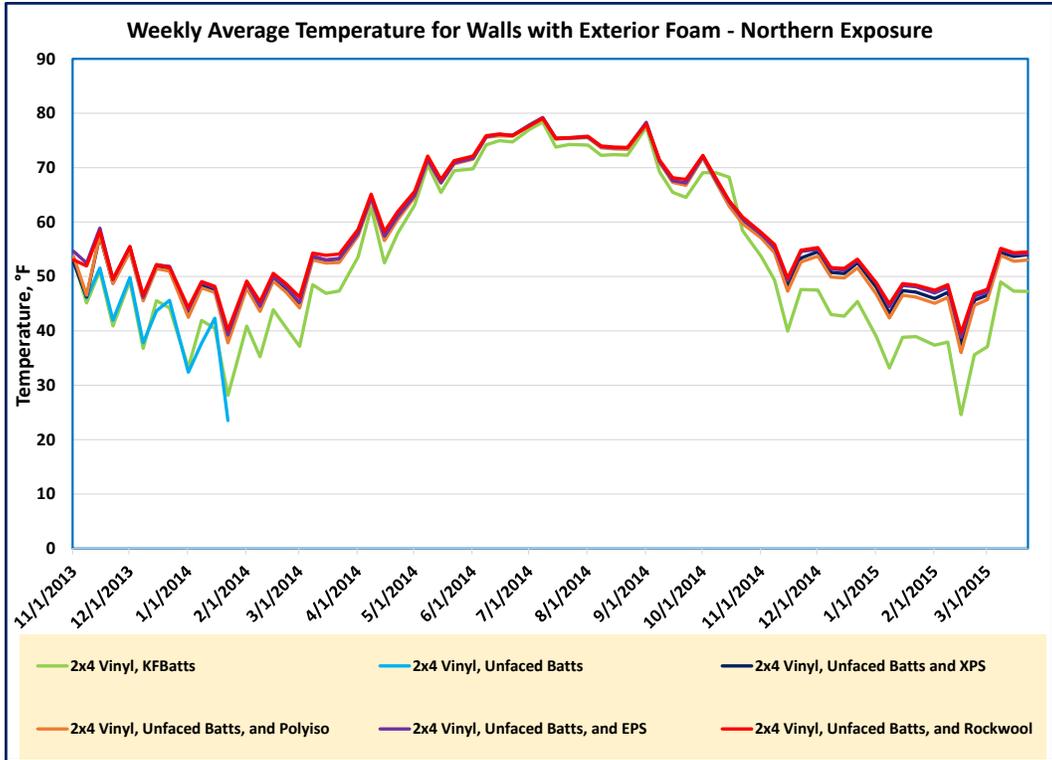
Figure 24. Weekly Average Temperature for Northern Exposure Walls with Exterior Insulations

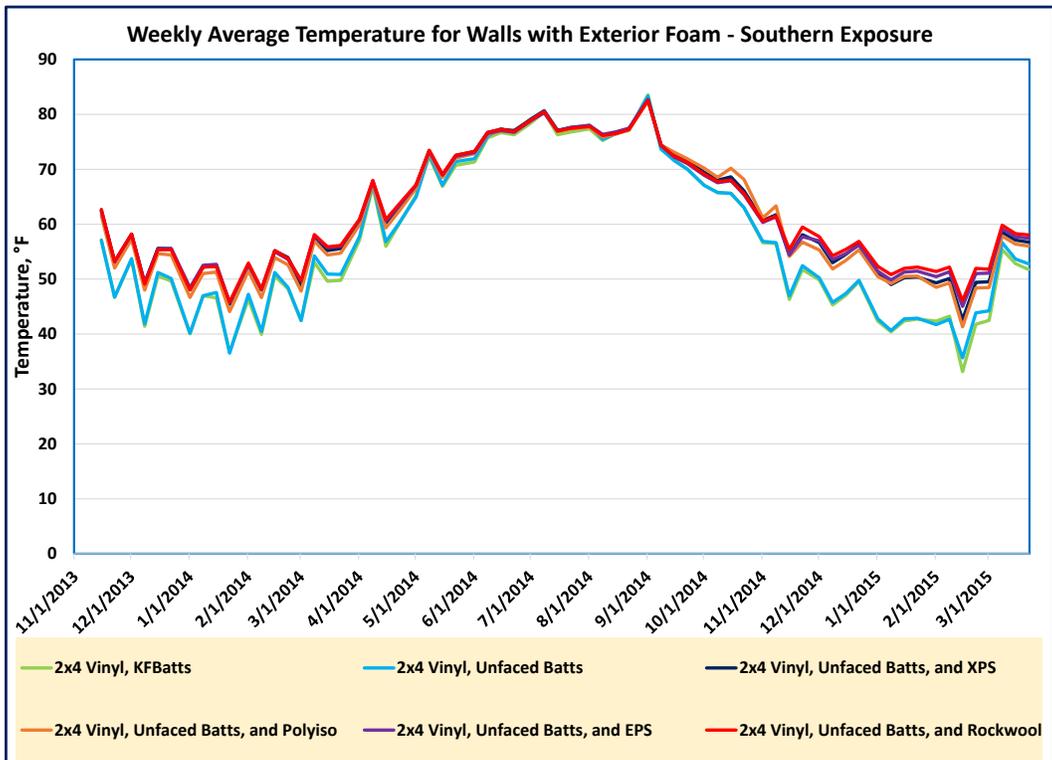
Figure 25. Weekly Average Temperature for Southern Exposure Walls with Exterior Insulations

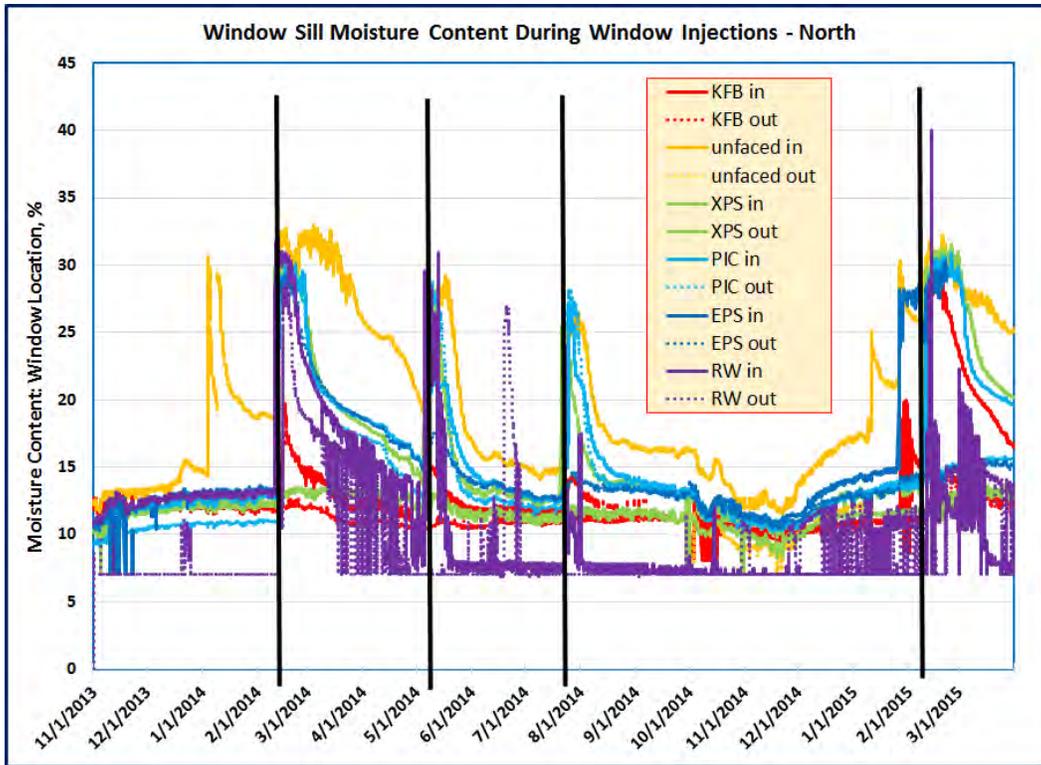
Figure 26. Daily Average Window Sill Moisture Content for Northern Exposure Walls with Water Injection

- For both north- and south-facing walls, the winter water injection events raised the window sill MC slightly over 30 percent. All south walls that experienced bulky water penetration in winter took less time (less than a month) than the north-facing walls to dry out below 20 percent.
- Among all north-facing walls with exterior insulation, the ones with PIC and XPS exterior insulations took the longest amount of time in the winter to dry out to below 15percent, as Figure 25 shows. This is caused by the low water vapor permeance value of the PIC material.
- At other times, the water injections raised window sill MC for all walls between 25 and 30 percent. Due to higher temperature and vapor drive, the walls were able to dry out to below 20 percent much more quickly compared to in the winter.

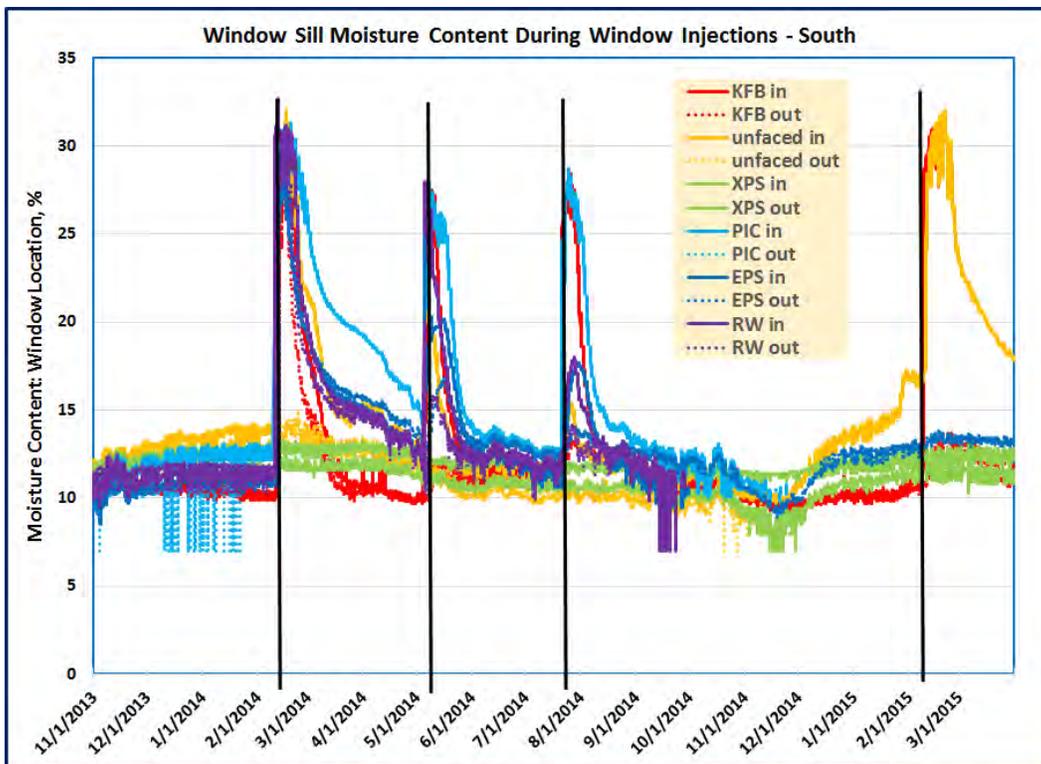
Figure 27. Daily Average Window Sill Moisture Content for Southern Exposure Walls with Water Injection
