Characterization of
Moisture Performance
of Energy-Efficient
Light-Frame Wood
Wall Systems
– Phase II

**Forest Products Laboratory
Joint Venture Agreement
13-JV-1111136-036**

December 2015

Report No. 3352.000.12292015

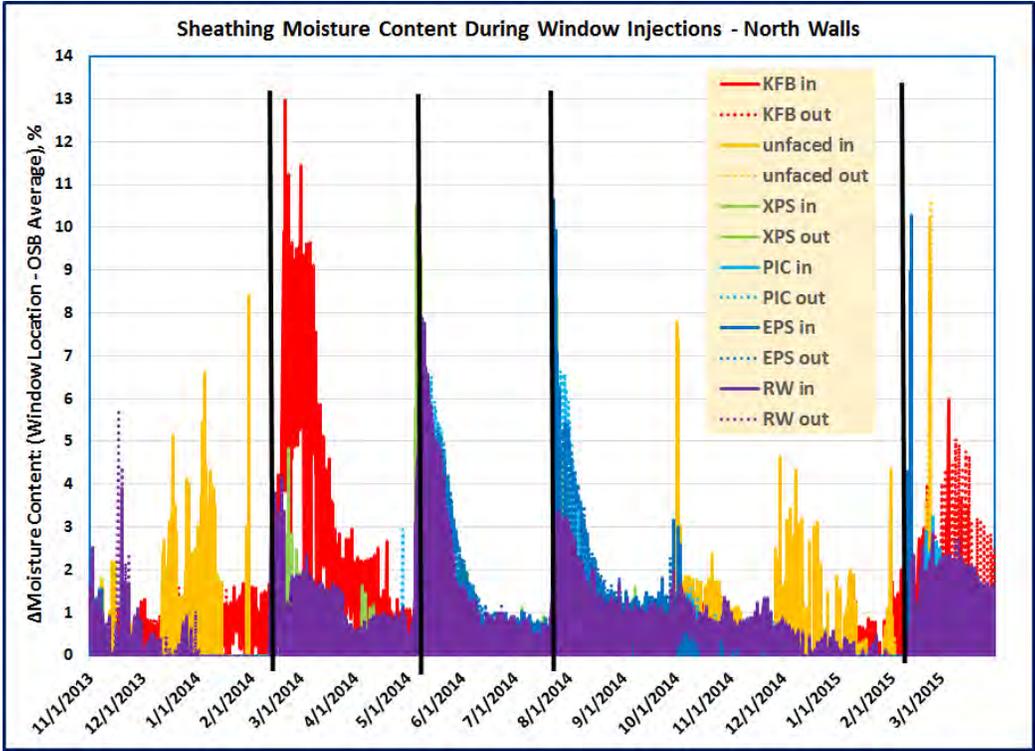
Figure 28. Daily Average Sheathing Moisture Content Differential for Northern Exposure Walls with Water Injection

Figure 28 and Figure 29 show the differential MC for the OSB sheathing at injection locations and the average OSB sheathing MC for the whole wall. After each water injection, the MC for the OSB sheathing of the window sill area where the injection occurred increased substantially compared to the whole wall OSB average MC. The following observations are made based on the field data shown in Figure 28 and Figure 29:

- For north-facing walls, the winter injections can bring the MC of window sill OSB up to 13 percent higher than that of the average wall OSB. The injections at other times raised the MC of the window sill OSB by 6 to 7 percent. For the south-facing walls, the increase was up to 19 percent in the winter, and 10-15 percent at other times.
- The OSB at the window sill area for the PIC wall took the longest time to dry out the additional moisture. Also note that the sensor for the PIC wall on the OSB near the window sill did not function well during the first winter of the test period. The OSB MC sensor at the window sill location for the 2x4 wall with vinyl siding and kraft-faced batts did not function correctly either.

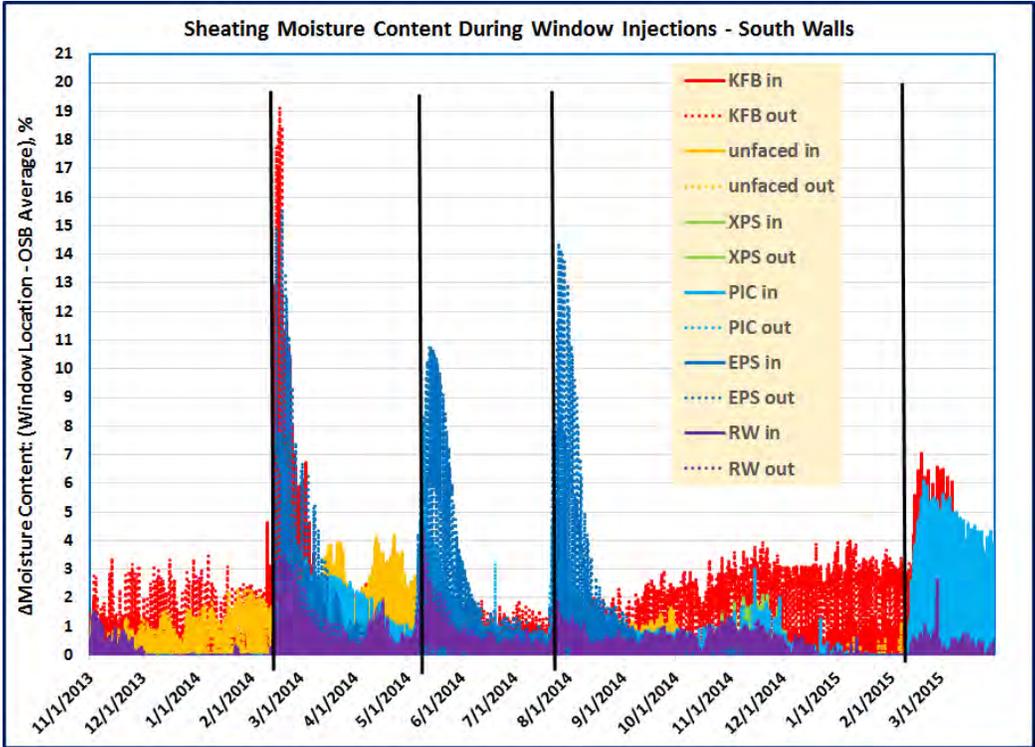
Figure 29. Daily Average Sheathing Moisture Content Differential for Southern Exposure Walls with Water Injection
