Evaluation of the Lateral Performance of Roof Truss-to-Wall Connections in Light- Frame Wood Systems

Prepared for
Forest Product Laboratory, Forest Service, U.S. Department of Agriculture
National Association of Home Builders

Prepared by
NAHB Research Center, Inc.
400 Prince George's Boulevard
Upper Marlboro, MD 20774

August 8, 2011

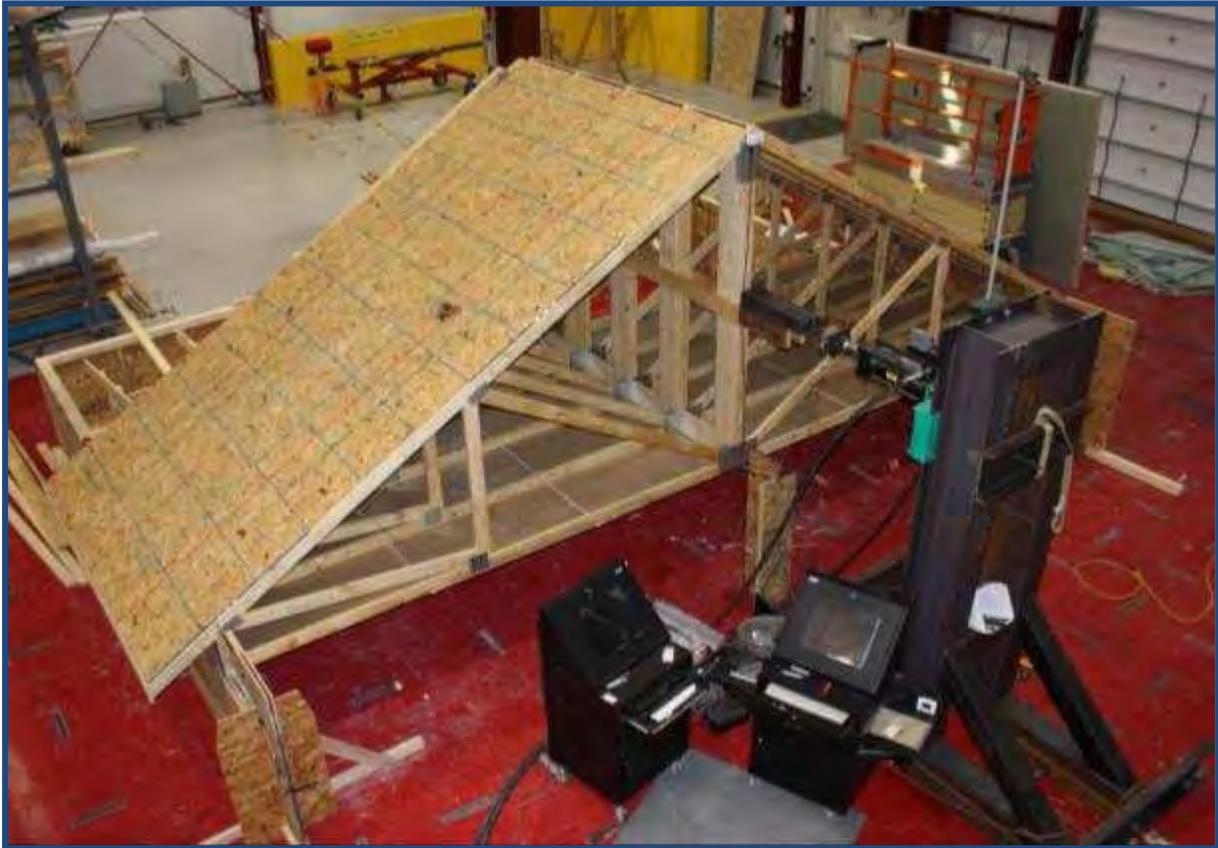
Figure 8 – Photo of test setup

Figure 7 shows the test set-up including the specimen, loading brace, and instrumentation. Figure 8 provides a photograph of the test set-up, reaction frame, and data acquisition system.

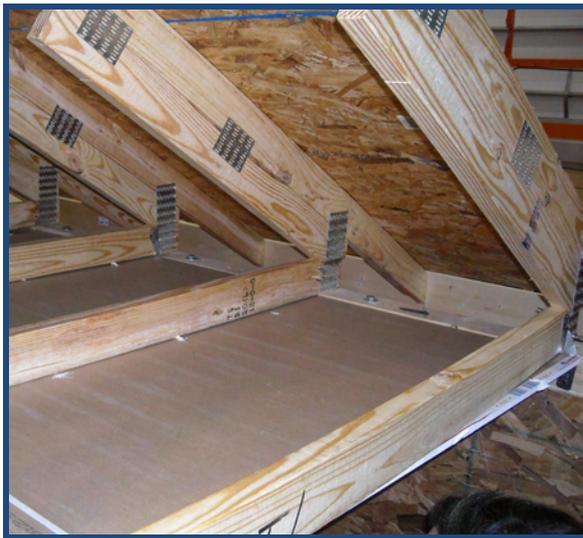
Figure 11 – Gypsum fastener tear-through (Specimen A)

Specimens A through C were intended to establish baseline capacities and performance characteristics for low- and high-heel roof systems without blocking or bracing the truss heel. The low-heel truss configuration (Specimen A) represents the highest allowable heel height by code that does not require blocking. Specimen A achieved a peak load of 5,140 lb (peak unit capacity of 255 lb/ft) and initial stiffness of 8,828 lb/in. Failure of Specimen A included initial fastener tear-through at the outer ends of the ceiling diaphragm near the knee walls followed by complete failure of the fasteners in the center gypsum panel (see Figures 11 & 12). Only minor rotation of the truss heels was observed during testing as well as minor rotation and buckling of the hurricane clips (Figure 13). Minor displacement of the truss top chord relative to the bottom chord at the heel joint was also observed; along with slight deformation of the metal connector plate at the heel joint (Figure 14).

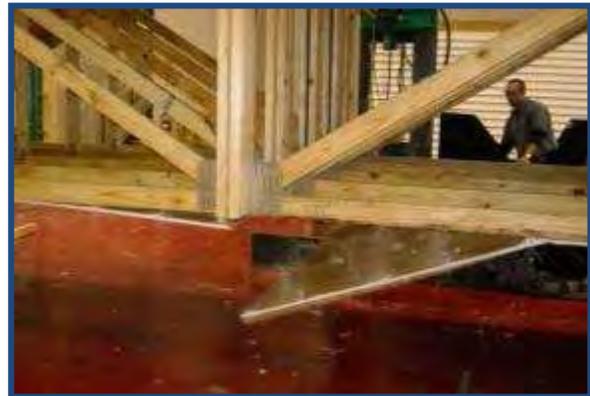
Figure 12 – Complete failure of gypsum fasteners (Specimen A)

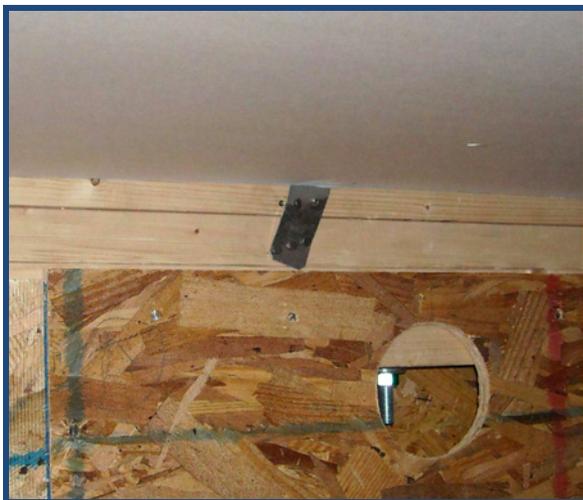
Figure 13 – Rotation of hurricane clip at failure (Specimen A)

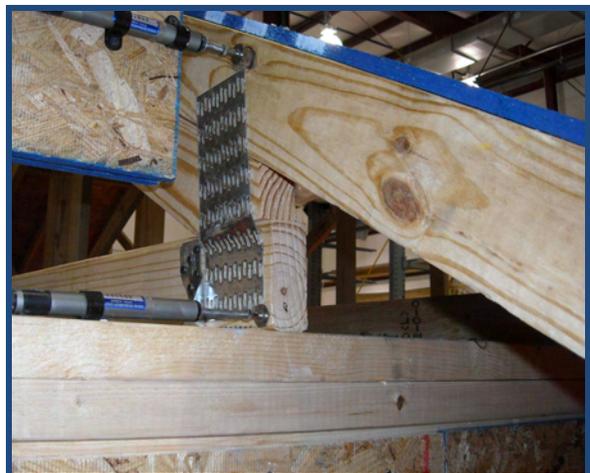
Figure 14 – Truss member displacement and metal connector plate deformation at heel joint (Specimen A)

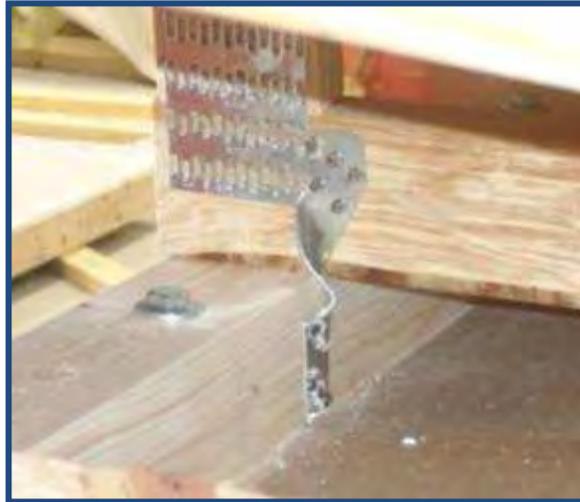
Figure 15 – Buckling of hurricane clip (Specimen C)

Specimen C was designed to evaluate the effect of a lower roof slope on the performance of the truss-to-wall connections. Specimen C was similar in construction to Specimen B and reached a peak capacity of 3,780 lb (peak unit capacity of 190 lb/ft) and initial stiffness of 3,950 lb/in. Specimen C exhibited similar damage and failure modes as Specimen B (i.e., gypsum fastener tear-through, significant rotation observed at truss heel). Additional damage was also observed in the form of buckled hurricane clips (Figure 15) and member separation at the heel joint metal plate connectors. Comparisons of both peak capacity and initial stiffness values between Specimen B (7:12 roof slope) and Specimen C (3:12 roof slope) yields a less than 10% difference in strength and stiffness performance between the two specimens, indicating that the degree of roof slope has a minimal effect on heel connection performance. Figure 16 provides a photo of the truss rotation observed in Specimen C at failure.

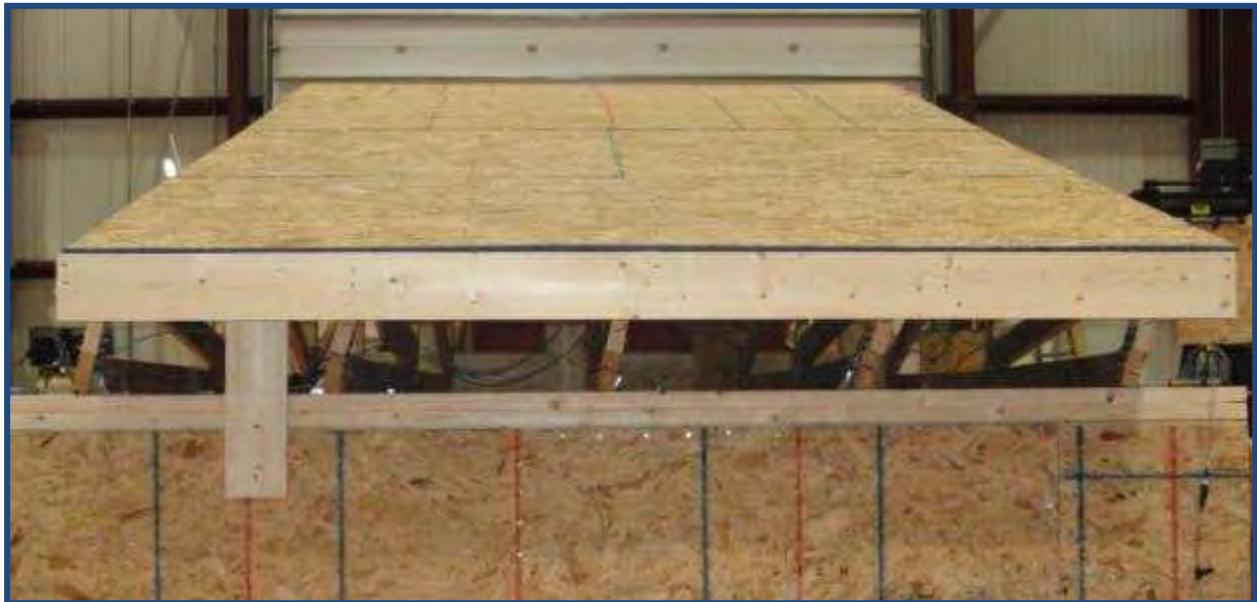
Figure 16 – Specimen C heel rotation at failure

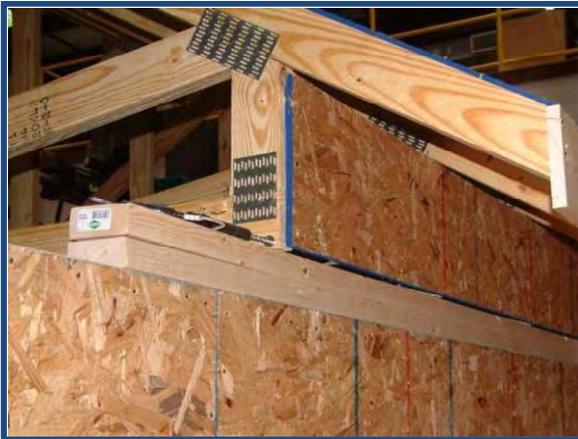
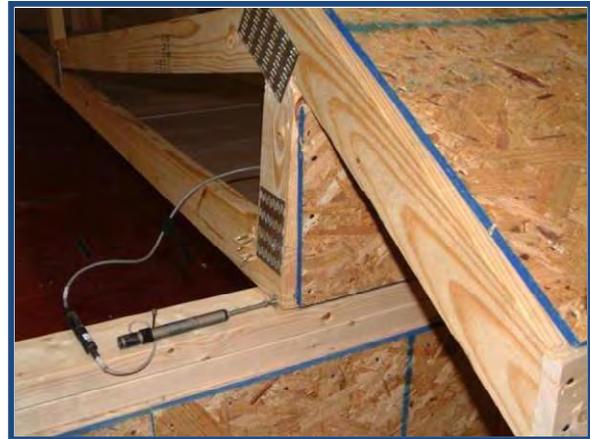
(a) Before test

(b) Post testing

Figure 17 – Comparison of rotation at Truss 5 (Specimen D)

occurred at the edges of the OSB bracing strip. The bracing of heel joints with OSB was also effective in controlling rotation of the truss. See Figure 17 for a comparison of the truss heel position prior to testing and after gypsum failure. Specimen E exhibited the same failure modes as Specimen D while achieving a peak capacity of 4,760 lb (or a peak unit capacity of 240 lb/ft) and initial stiffness of 32,224 lb/in. While this peak capacity from Specimen E is 7% less than the peak capacity of the low-heel configuration (Specimen A), the additional nailing of the OSB bracing strip to the supporting wall below in Specimen E increased the initial stiffness of the specimen threefold over both the OSB bracing strip without top plate nailing and the benchmark low-heel specimen (3.1 times and 3.6 times greater, respectively).

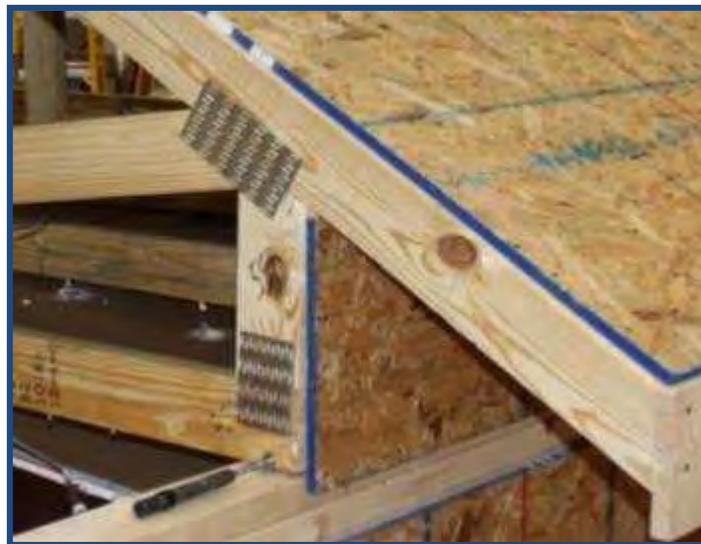
Figure 18 – Truss rotation of Specimen E at failure (Truss 5)

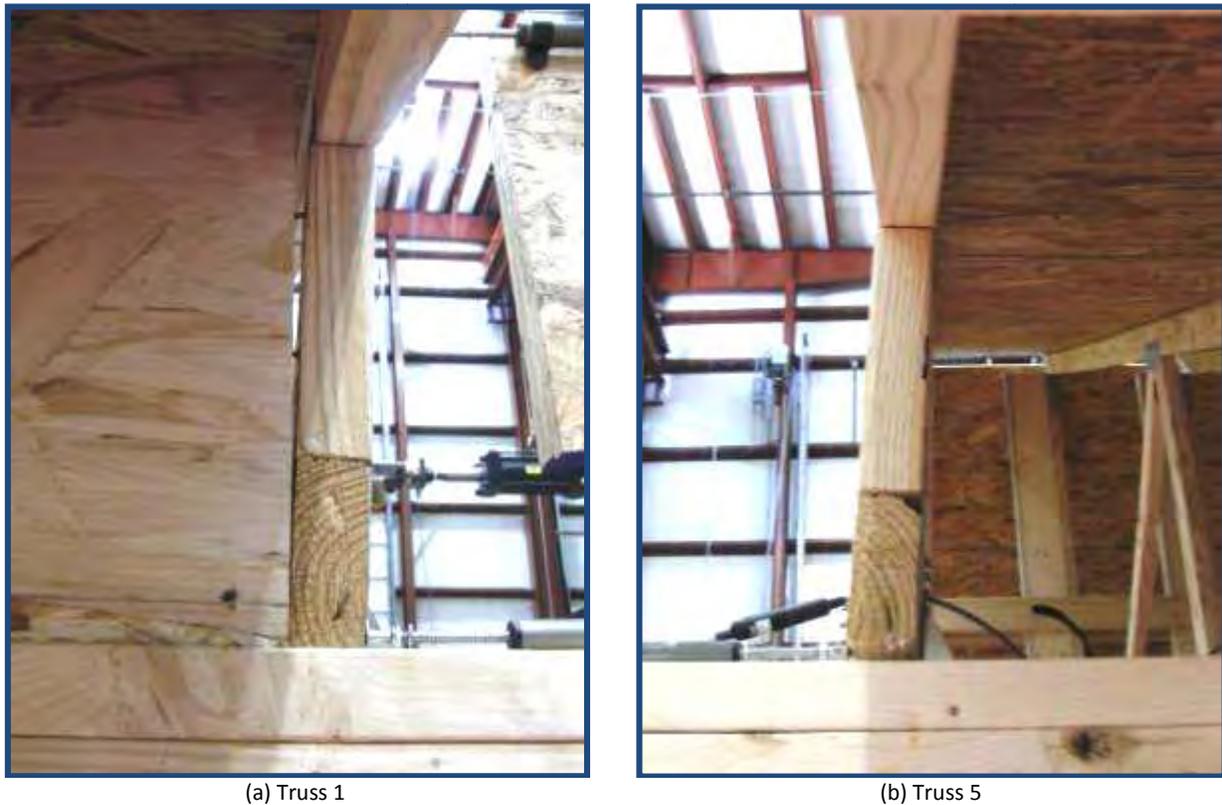
Figure 19 – Comparison of truss heel rotation (Specimen F)

observed and described for previous specimens. The same moderate rotation was observed at both the front two trusses (where blocking was installed) and the fourth (where no blocking was installed). This visual observation was confirmed through displacement measurements at both locations indicating that the single blocked bay provides rotational restraint to the entire specimen (i.e., the effect of the blocking is not localized). Figure 19 shows a comparison of the rotation of the first and last trusses.

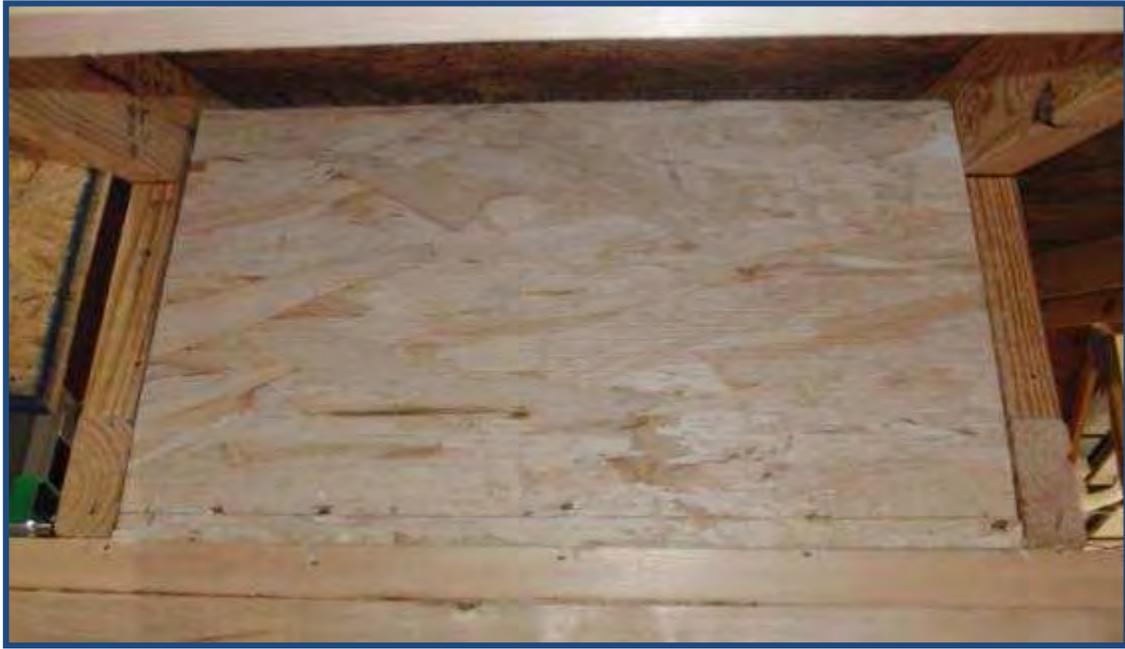
Figure 20 – Rotation of truss heel at blocking location (Specimen G)

The 50% blocked specimen (Specimen G) reached a peak load of 4,520 lb (unit peak capacity of 225 lb/ft) and an initial stiffness of 26,581 lb/in and exhibited similar failure modes as Specimen F, including the primary failure mode of gypsum fastener tear-through. Some rotation of the trusses relative to the blocking panels was also observed, as shown in Figure 20. When compared to the tested benchmark capacities of Specimens A and B, the 50% blocked specimen exhibited a 28% increase in capacity over the unblocked high-heel specimen and showed a 12% decrease in capacity compared to the unblocked low-heel specimen. Interestingly, the addition of the second blocking panel only resulted in a 12% increase in stiffness over the 25%-blocked specimen (Specimen F). Both blocked specimens, however, exceeded the low-heel baseline configuration by more than a factor of 2.5.
