Evaluation of Nailed Roof-to-Wall Connections for Resistance to Uplift

National Association of Home Builders

**FINAL REPORT
August 2008**

Report #5822-04_081108

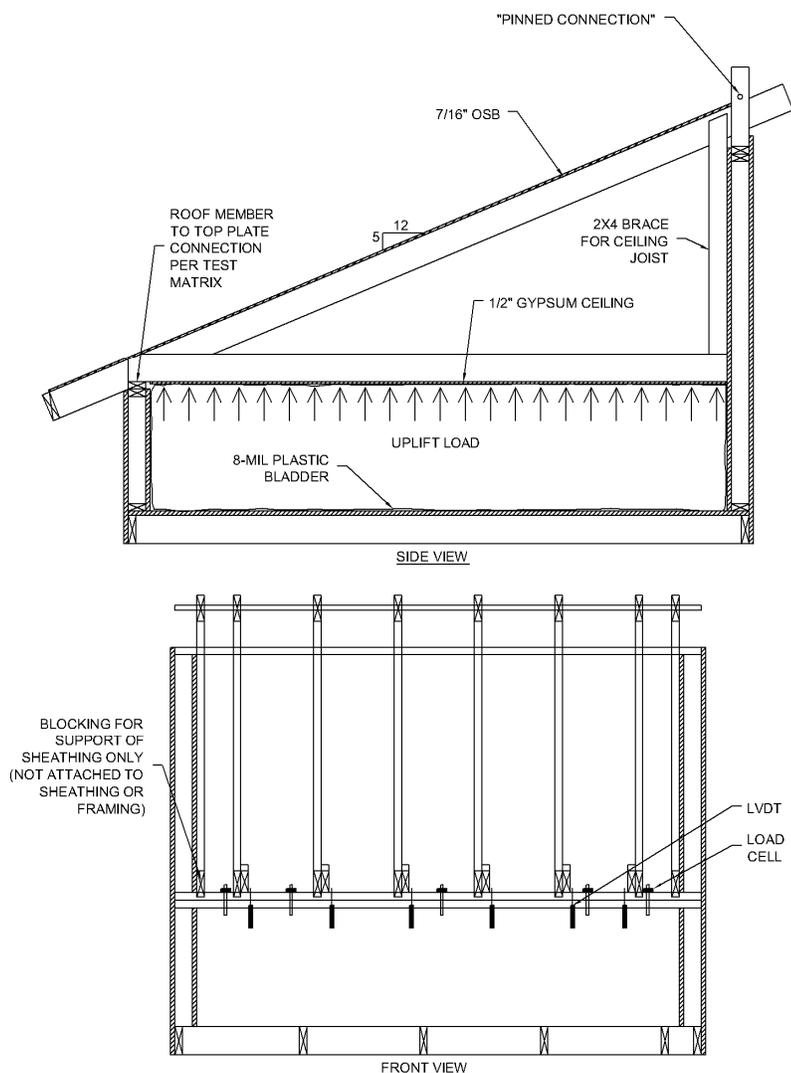
Figure 1 – Uplift set-up of specimen with ceiling joists

Figures 1, 2, and 3 show the test setup for the three specimen configurations; conventional rafters only, conventional rafters with ceiling joists and metal plate connected (MPC) wood trusses, respectively. The roof specimens were 8 feet wide (in the direction perpendicular to framing members) by 10 feet long (horizontally in the direction parallel to framing members) with a 12-inch overhang. For the specimens with rafters spaced at 16 inches on center, this resulted in a total of 6 roof-to-plate connections tested as part of one assembly. For the specimens using trusses spaced at 24 inches on center, this resulted in a total of 4 roof-to-plate connections tested as part of one assembly. The specimens were framed such that the first connection occurred at the distance equal to half the roof member spacing from the edge of the specimen. This allowed for equal loading on all connections. Blocking was provided for the sheathing at the specimen edges. This practice is consistent with ICC-ES procedures for testing assemblies with multiple sheathed members (ICC-ES AC-86, 2008).

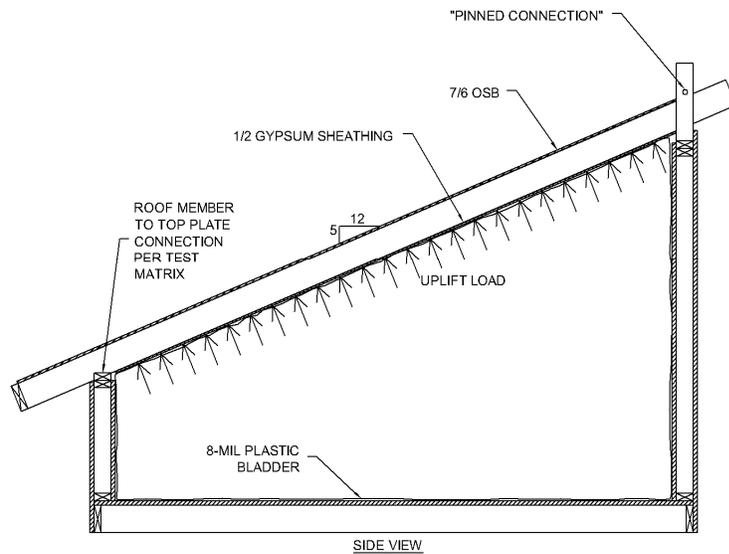
Figure 2 – Uplift set-up of specimen without ceiling joists

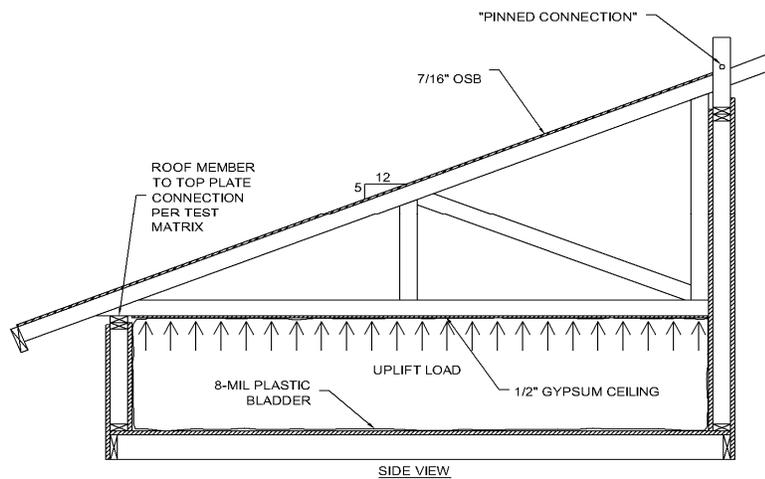
Figure 3 – Uplift set-up of specimen with MPC roof trusses

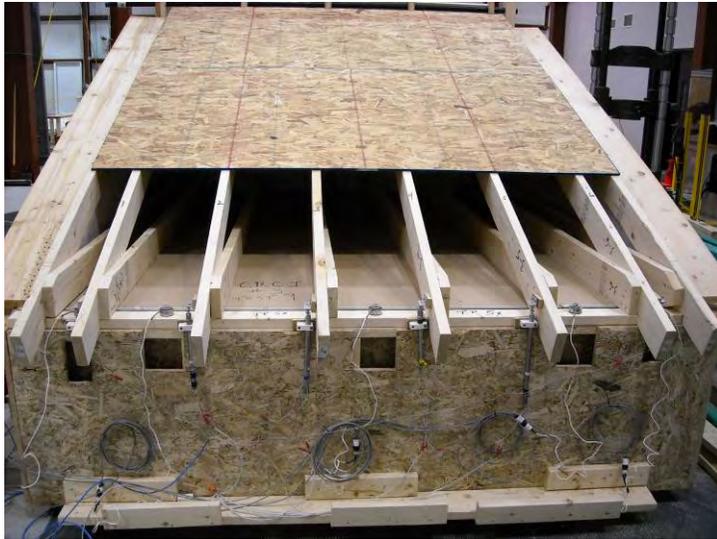
**Figure 4 – Uplift set-up instrumentation
(OSB panel is not attached to show connections and
instrumentation)**

Figures 4 and 5 show photos of the test setup. The specimens were subjected to a uniform uplift load applied using a pressurized 8-mil polyethylene bladder. The bladder was placed inside a structurally reinforced test box and the specimens were placed on top of the box to simulate typical roof conditions. The box was built using wood framing sheathed on both the interior and exterior faces with 7/8-inch-thick OSB.

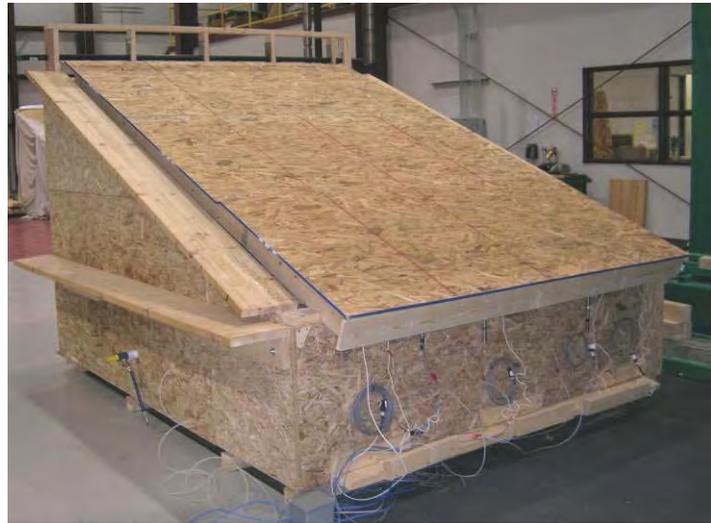
Figure 5 – Uplift specimen ready for testing

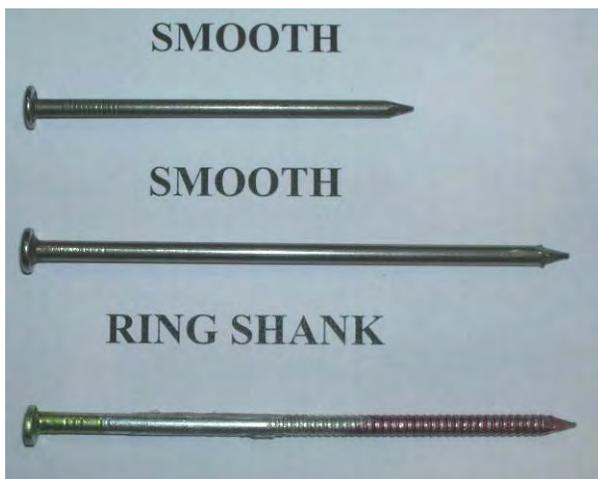
**Figure 6 – Pneumatic nails used in roof-to-plate
connections**

The smooth-shank pneumatic nails used in the roof-to-plate connections were manufactured by Senco and the ring-shank pneumatic nails were manufactured by Paslode (Figure 6). The smooth-shank nails had a symmetric full round head. The ring-shank nails had an asymmetric full round head (Figure 7). Because the IRC allows the use of smooth-shank common nails without coatings, all pneumatic smooth-shank nails were chemically cleaned of any adhesive prior to testing. The toe-nails were installed using a pneumatic nail gun at an angle approximately between 35 and 40 degrees off vertical and with the head of the nail located approximately 1/3 of the total nail length from the top plate (Figures 8 and 9). The location of the nail head is in accordance with the requirements of Section 11.1.5.4 of the National Design Specification for Wood Construction (NDS, 2006). The angle was slightly greater than 30 degrees recommended by the NDS because the weight and configuration of the nail gun made it difficult to position it at a 30-degree angle. It should be noted that some of the framing members did split during installation of the toe-nails. However, splitting to the extent shown in Figure 10 typically occurred in no more than one framing member per specimen.

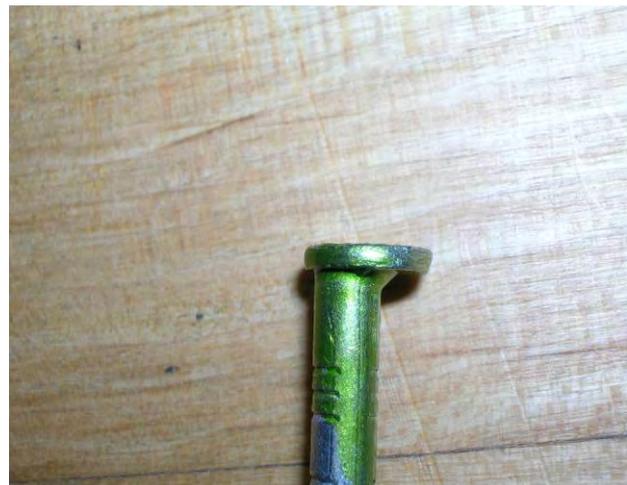
**Figure 7 – Asymmetrical full round head of
Paslode 16d ring-shank nails**

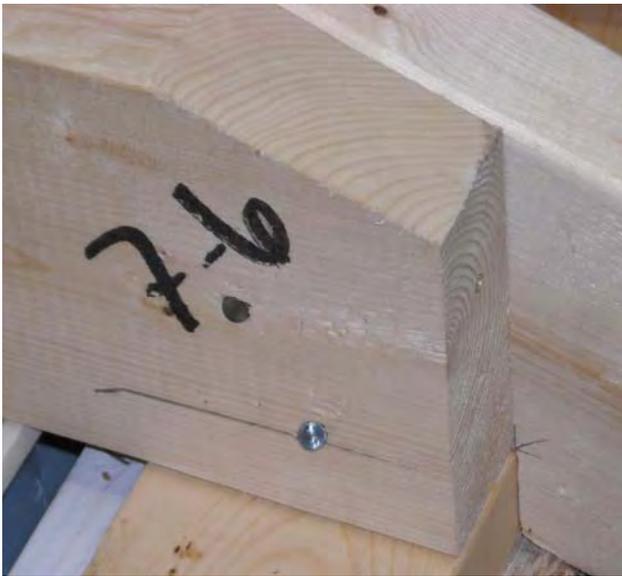
Figure 8 – Installation of toe-nails

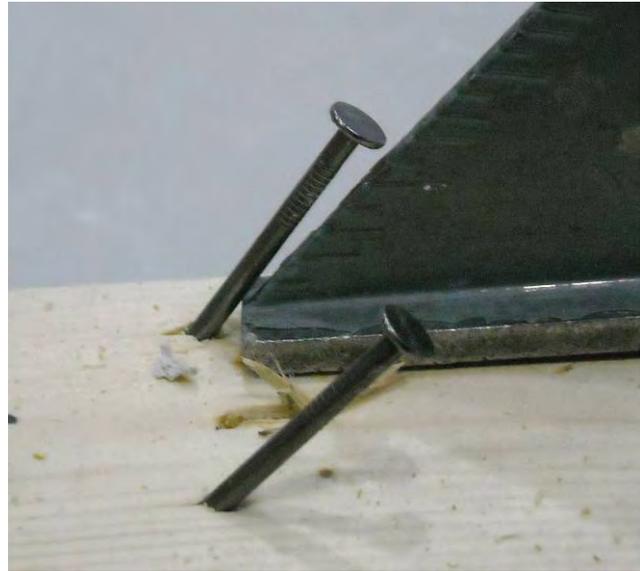
**Figure 9 – Angle of installed toe-nails
(Toe-nails after pull-through failure)**

As discussed previously in the Methods section, the nails were generally installed at an angle ranging approximately between 35 and 40 degrees. This installation practice reduced the penetration depth by 4% to 8%. However, all calculations of design values for the purpose of comparing to test values were performed for a 30-degree angle. Although this is a conservative approach, it allowed for direct comparisons to design specifications and to tabulated values. Moreover, the increased angle has a potential to trigger a nail bending mechanism in lieu of direct nail withdrawal.

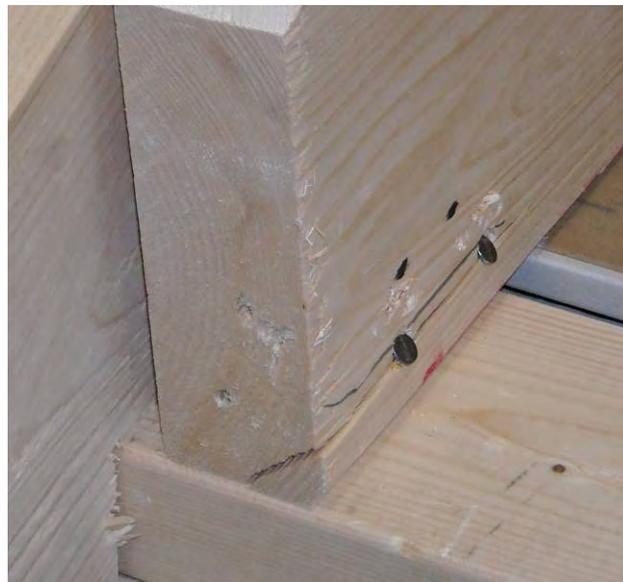
Figure 10 – Splitting of ceiling joist during installation of toe-nails

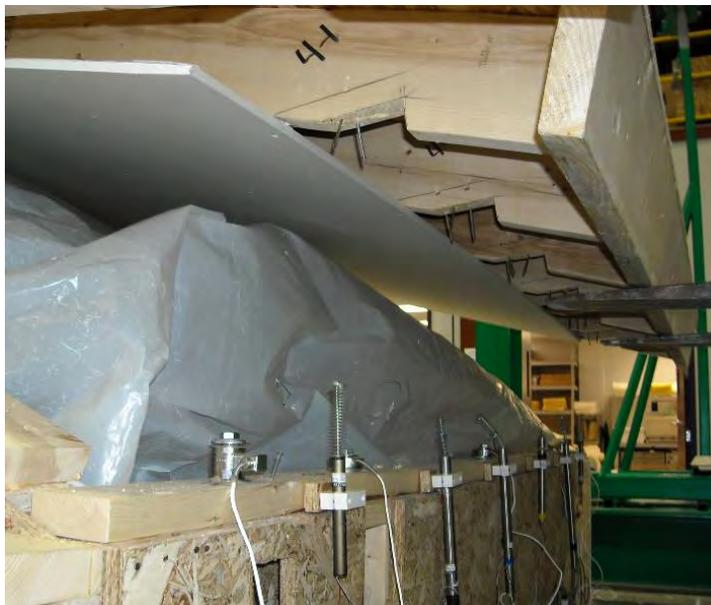
Figure 11 – Specimen after failure

The specimens failed in a manner that the entire roof system separated from the double top plate, i.e., it was a system failure rather than failure of individual connections (Figure 11). Load per connection was calculated by summing the load cell forces across the length of the top plate and dividing by the number of connections. It should be noted that peak loads for different load cells occurred at different times indicating a load redistribution mechanism between stronger and weaker connections. The maximum capacity of the system was taken as the highest total force resisted by the system (not the summation of the individual peak loads for each load cell).

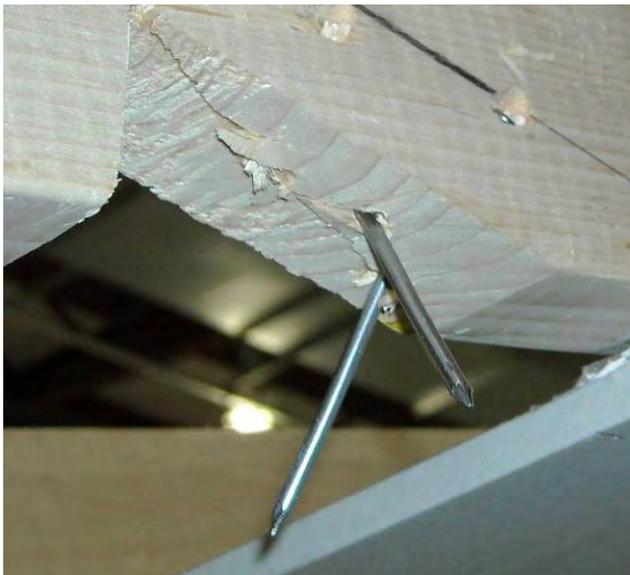
Figure 12 – Nail withdrawal and rafter splitting

Rafters were attached to the top plate using three 16d pneumatic box nails in accordance with RB207. The average capacity was 710 lb per connection. Figures 12 and 13 show typical failure modes including nail withdrawal from the top plate, pulling through the rafter, and rafter splitting. The predominant failure mode was nail withdrawal from the top plate. It is interesting to note that compared to specimens with a ceiling joist, rafter-to-wall connections are subject to both uplift and thrust forces. There was no evidence of reduction in capacity due to such loading. In fact, there is a potential for improved friction between the nail and the wood due to the force normal to the body of the nail.

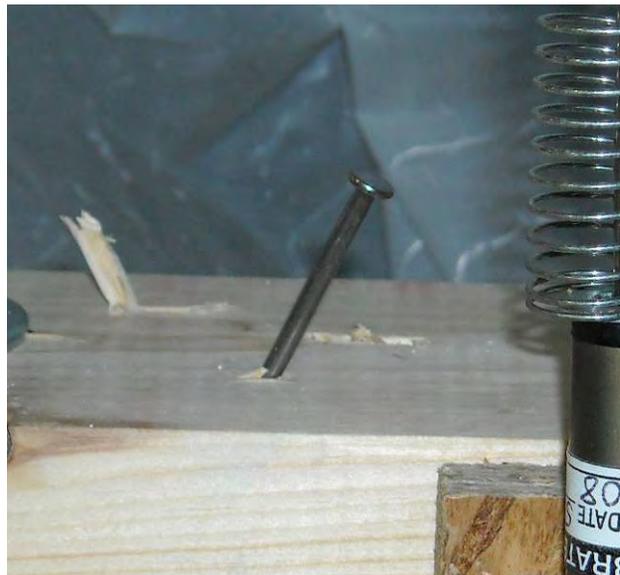
Figure 13 – Nail after pulling through rafter

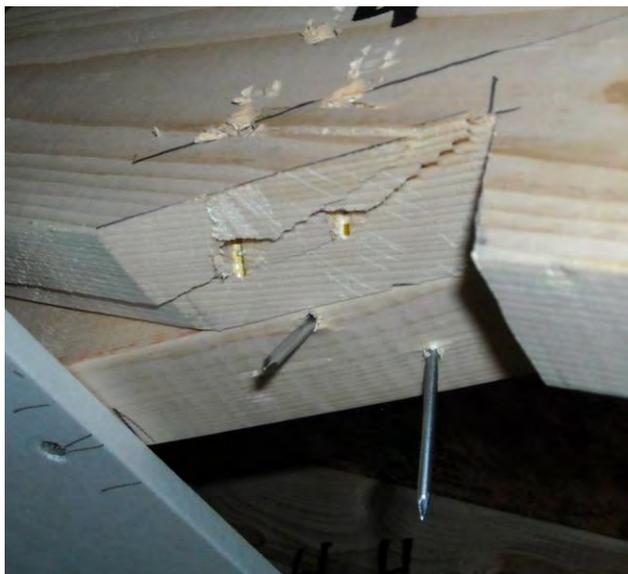
Figure 14 – Nail withdrawal of the 8d nails and pull through of 16d nails

The first configuration under this group is in accordance with the fastening schedule of RB207: three 8d box nails in the joist and two 16d box nails in the rafter. Figure 14 shows a typical failure mode that included withdrawal of 8d nails along with pull-through of 16d nails and splitting of the rafters. Although the total number of nails increased compared to the conventional rafter-only connection, the average capacity of this connection was 679 lb – a 4.4% reduction. This result indicates that 8d box nails do not have sufficient penetration into the top plate to develop comparable performance as 16d box nails even if normalized by length and diameter. As evidence, the safety margin relative to the allowable design values is reduced and is the lowest among all other tested connections that do not contain 8d nails (Table 2).

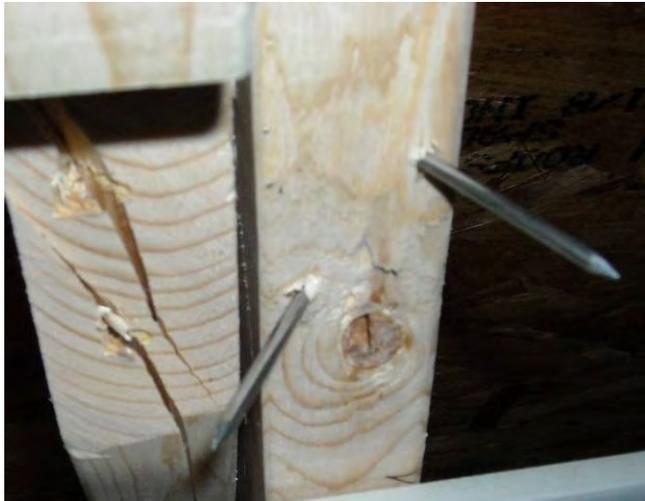
Figure 15 – Nail withdrawal and pull-through failure modes of 16d nails

In the second configuration under this group, the joists were attached to the top plate with two 16d box nails in lieu of three 8d box nails. Therefore, a total of four 16d nails were used per joint: two per rafter and two per joist. The intent for this configuration is to provide an alternative connection that uses a single nail type to allow for simplified construction. The typical failure mode for this configuration was a combination of withdrawal from the top plate along with pull-through and splitting of the roof member (Figures 15 & 16). The average connection capacity increased to 791 lb. The safety margins compared to the allowable design values have also increased. Although the total depth of penetration of three 8d box nails is greater than the total depth of penetration of two 16d box nails (4.6 inches for three 8d box vs. 4.3 inches for two 16d box), the total connection capacity using four 16d nails is 16% higher. This observation confirms the trend observed in the previous configuration that 8d box nails are less effective in toe-nail applications than 16d box.

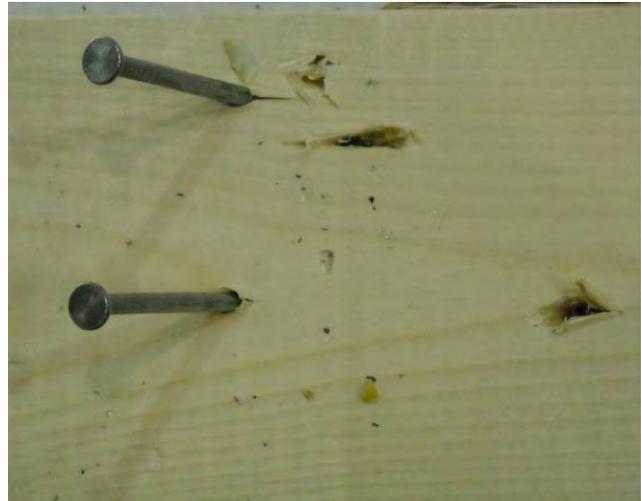
Figure 16 – 16d nails in plate after pull-through failure

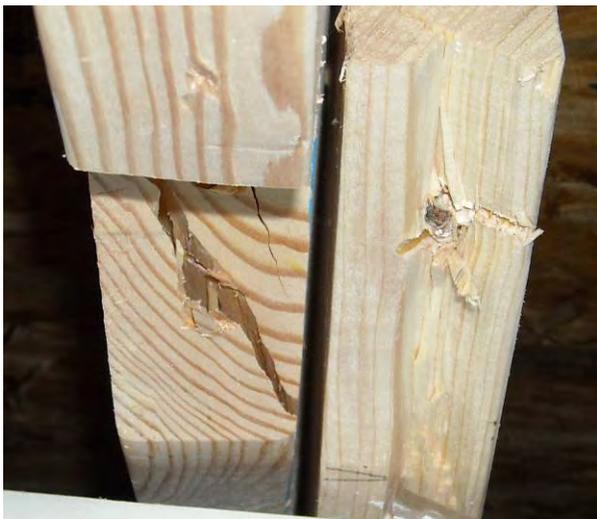
Figure 17 – Pull-through failure of all ring-shank nails

The third configuration under this group included testing of ring-shank nails. The intent of this configuration is to establish an upper bound capacity for toe-nailed connections. A total of four 16d box ring-shank nails were used to allow direct comparison with the previous configuration. The average capacity was 848 lb per connection, a 7.3% increase from the 16d box smooth shank results. The typical failure mode was associated with nails pulling through the roof members (Figures 17 & 18). Therefore, the limiting factor for the performance of ring-shank toe-nails is the capacity of the wood framing, capping the total connection's capacity at below 900 lb (the first test of this configuration reached 896 lb per connection). As previously noted, the ring-shank nails had an asymmetric round head configuration. It is possible that a different type of nail head can improve the pull-through performance.

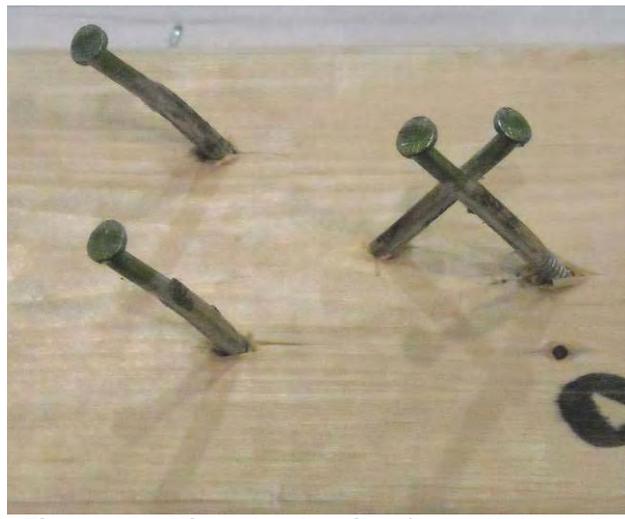
Figure 18 – Ring-shank nails after pull-through failure

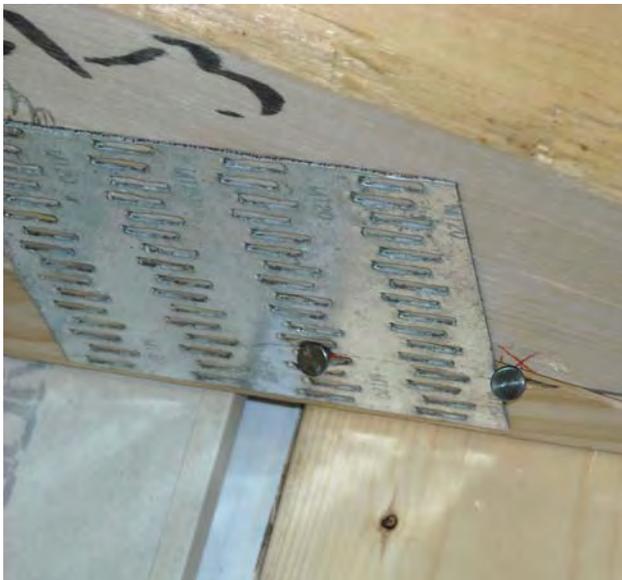
Figure 19 – Installation of one nail through the truss plate and one nail adjacent to the truss plate

One connection configuration of a MPC wood truss roof was tested using three 16d box nails in accordance with RB207. Because this connection is affected by the location of the truss plate relative to wood framing, the truss heel joint was selected such that the location and size of the truss plate allowed for two nails be driven through the truss and one nail directly through the wood (Figure 19). This configuration allowed to capture the effect of a nail located near the end grain of the beveled edge, which has a potential propensity to splitting. Figure 20 shows the typical failure mode that included withdrawal of the nails from the top plate. The metal truss plates reinforced the wood of the bottom chord minimizing the potential for wood splitting and eliminating the nail pull-through failure mode. Even where local splitting of the bottom chord occurred near the nail installed at the beveled edge, the truss plate was effective at keeping the wood member together such that all nails withdrew from the top plate. The capacity of the truss-to-roof connection was 671 lb per joint, a 5.5% reduction relative to a three 16d box nail connection for conventional rafters. However, the performance of the two configurations is considered equivalent, as this reduction can be attributed primarily to the increased framing spacing of 24 inches on center. This increased spacing contributed to reduced stiffness of the boundary conditions at the edge trusses due to the increased width of the free edge (12 inches for trussed spaced at 24 inches on center vs. 8 inches for framing spaced at 16 inches on center). In a complete roof assembly, the sheathing is either continuous or attached to boundary members, resulting in increased boundary stiffness.

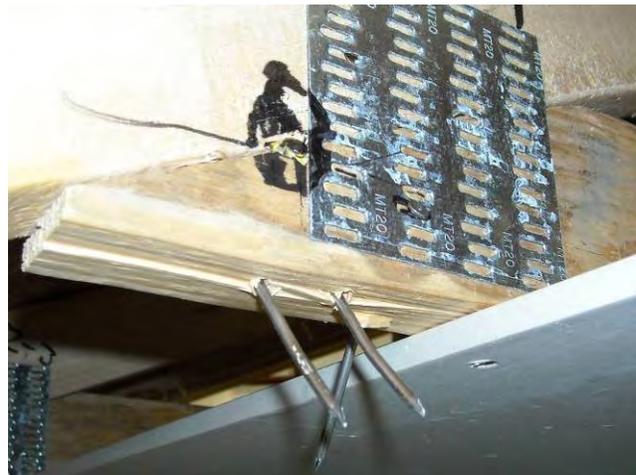
Figure 20 – Nail withdrawal failure mode for truss configuration

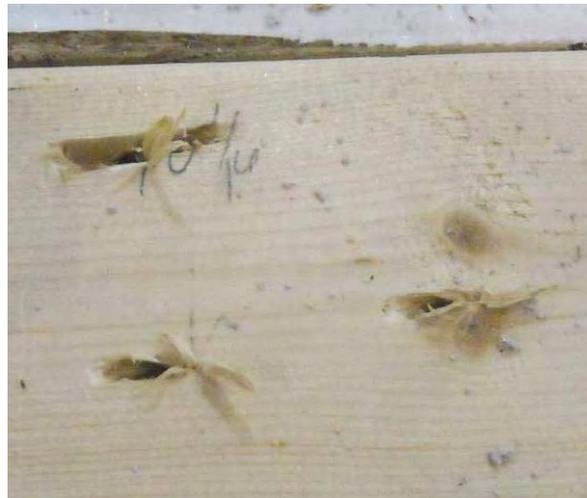
Figure 21 – Local tearing/crushing of top plate associated with withdrawal failure mode

Where the primary failure mode was withdrawal of the nails from the top plate, the wood around the nail was subject to crushing and tearing to allow for withdrawal of an angled nail to occur (Figure 21). This response mode should also in part explain the improved performance of 16d nails vs. 8d nails – the longer nails have an increased horizontal projection engaging more wood to resist tearing. This toe-nail response is different from a straight nail pullout where the resistance is controlled only by the friction between the nail and the wood fibers.
