Addendum to the May 2018 Report "Moisture Performance of High-R Wall Systems" by Home Innovation Research Labs

September 2018

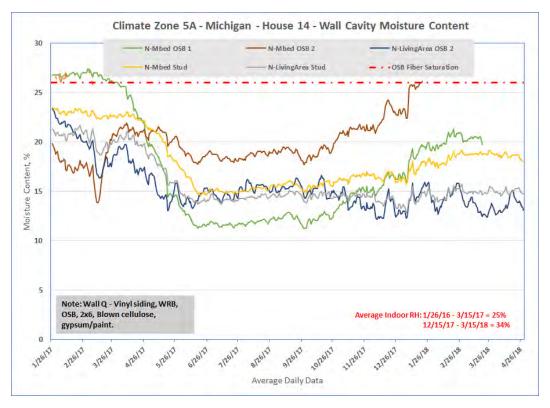
Figure <u>A</u>19. OSB sheathing and stud moisture content for Climate Zone 5A, Michigan (7), House 14

- Three sensors indicated a spring drying trend.

- The interior RH levels during the winter seasons were 40% on average40-45%. This was somewhat lessnot far from than the results of the previous monitoring study, which showed RH levels exceeding 60%. This is one of the few sites where the second winter outdoor temperatures were a few degrees higher that the first winter (minimum temperature 25.9°F in 2016-2017 vs 29.6°F in 2017-2018).
- If a wall system with reduced seasonal fluctuations was desired, the use of a Class II interior vapor retarder (e.g., Kraft paper, membranes) should be considered. Installing cladding in a vented manner can provide another mechanism for moisture dissipation to the outdoors.

[Note: House 4 and House 14 were switched in the main report. This error is corrected in this Addendum.]

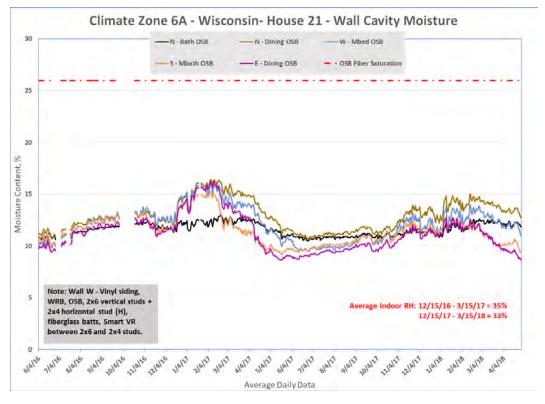
Figure A26. OSB sheathing moisture content for Climate Zone 6A, Wisconsin (1), House 21

Figure 26-Wall W is a unique system that effectively consists of two walls—an exterior 2x6 wall and an interior 2x4 wall—separated by a sheet of a smart vapor retarder. Both walls are insulated with fiberglass batts. To facilitate review of the data, measured moisture content is graphed across three separate charts: exterior OSB (Figure A26), studs out of the vapor retarder (Figure A27), and studs inside the vapor retarder (Figure A28). The charts shows the summary results for the OSB sheathing and stud daily moisture content for House 21, located in Wisconsin, Climate Zone 6A. The following observations can be made:

- WUFI simulations were consistent with the observed trends; however, there were significantly underpredicted moisture content levels compared to data from most sensors.

- The interior RH levels during the winter season were 35% on average. This is within the expected range for this climate zone.

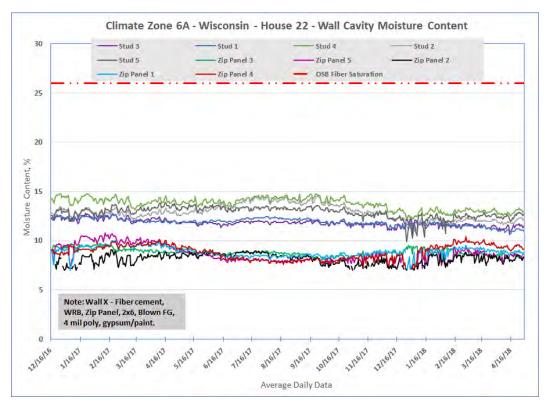
Figure A29. OSB sheathing and stud moisture content for Climate Zone 6A, Wisconsin (2), House 22

Figure A29 shows the summary results for the ZIP sheathing and stud daily moisture content for House 22, located in Wisconsin, Climate Zone 6A. The following observations can be made:

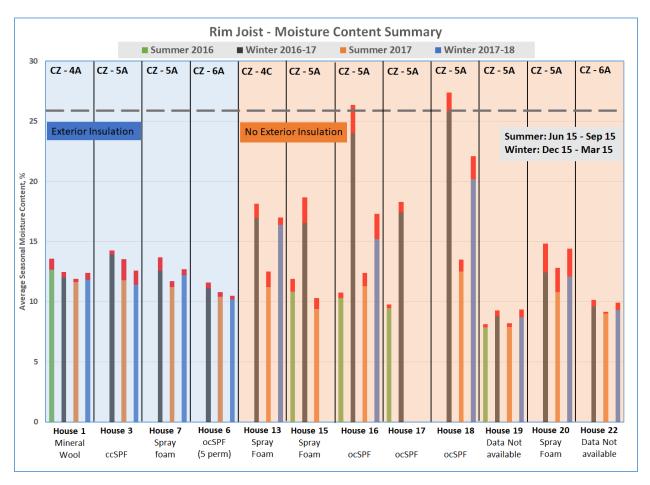
Figure A30. Summary: seasonal peak and averages moisture content of rim joists

Because the permeability of the interior insulation is not known for several houses, it is not always clear which element or combination of elements are most critical to the observed performance. The following observations can be made based on the available data:

- Walls with exterior insulation remained at low moisture levels and did not show significant seasonal fluctuations. For Climate Zone 4A (House 1), the rim area was vapor open in both directions. For climate zones 5A and 6A (hHouse 3, 6, 7), foam products were installed on both faces of the rim joist. For all walls with exterior insulation, the moisture content was less than 15% and did not exhibit significant seasonal fluctuations.
- For houses without exterior insulation, rim joists with open-cell spray foam showed larger seasonal fluctuations; however, these were not necessarily to the levels approaching the fiber saturation point and most houses showed lower moisture content levels during the second heating season even though the outdoor temperatures were lower. Those houses that did not show seasonal fluctuations (Houses 19 and 22) likely used closed-cell spray foam.

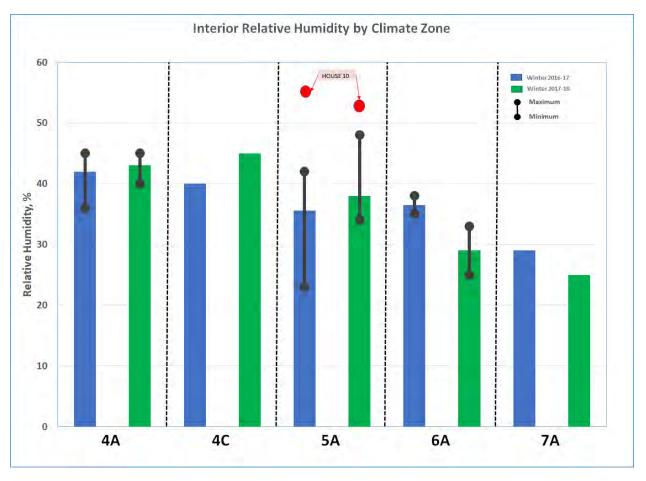
Figure A31. Summary: seasonal peak and averages moisture content of rim joists

The average RH level remained at less than 450% for all homes with the majority of homes at below 45%. Therefore, the combinations of the building enclosure, ventilation system, and occupant behavior in all monitored homes resulted in acceptable interior RH levels. The observed levels were generally consistent with the levels measured in previous studies.

One outlier is House 10 in Climate Zone 5A. This is the only house in the study that is a renovation rather than new construction. A new addition to this existing house was monitored. The owner also indicated that they were running a humidifier. The interior RH averaged in the low to mid 550s% during the winter and peaked at 62% each time. Although this is an older house renovation, the more likely cause of the elevated RH levels is the humidifier.
