SPRAY FOAM Insulation & Termites

This document addresses questions pertaining to inspection for, and treatment of, potential termite infestations in buildings using SPF insulation. It provides basic information about termite identification, inspection and treatments methods as well as discusses the importance of air-sealing and insulation of critical areas using SPF. It also presents code-compliant solutions to address these concerns.

Spray Foam Insulation & Termites

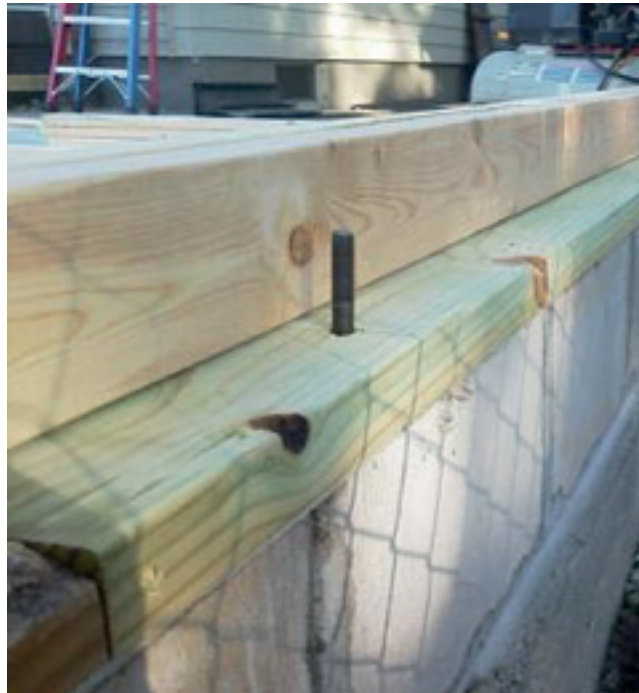
FIGURE 9. Termite resistant wood near the foundation

- Borate treatment of select wood members (Figure 6)
- Termiticide application on the surrounding ground areas (Figure 7)
- Termite baiting systems (Figure 8)
- Use of preservative treated wood or termite resistant wood (Figure 9)*
- Physical barriers (sheet metal or wire mesh) between foundation and framing (Figure 10)
- In areas of very heavy termite infestation:
 - o The use of foam plastic insulation is *not permitted* on the exterior face of walls, or below footings, foundations or slabs that are below grade.
 - o Foam plastic on above grade walls must be 6" above the ground.

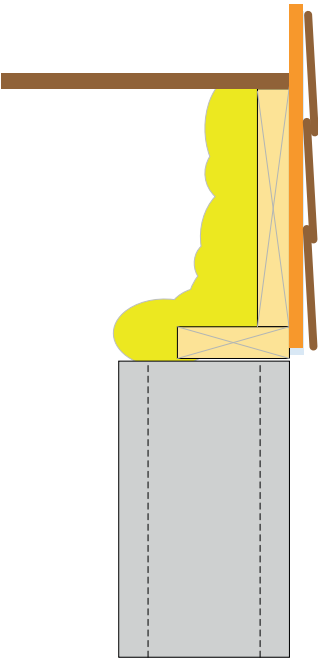
SPF is often used by builders of new homes and weatherization contractors in existing homes at the framing-foundation area, and is often regarded as an especially cost-effective and reliable means to insulate and air seal these critical areas⁸. Figure 12 shows the installation of closed-cell SPF from beneath the subfloor to the top of the foundation, providing long-lasting insulation, air sealing, and moisture control.

FIGURE 12. Closed-cell SPF insulation at the foundation-framing area

The concern by some pest control and inspection companies with these permanent applications of foam plastic in the rim joist, shown in Figures 12 and 13, is that it does not permit removal of the insulation for traditional visual inspection of the sill plate, band/rim joists or the ends of the floor joists. This challenge can be addressed through use of newer technologies when inspecting for termites.

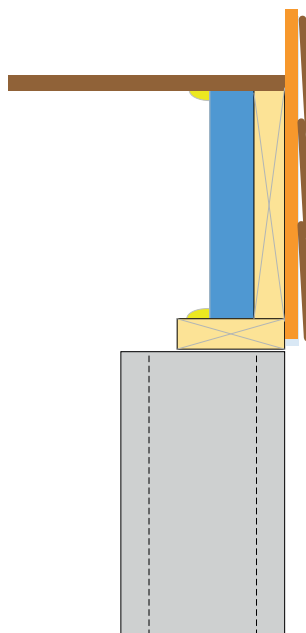
Alternative methods of insulating these areas may include the use of cut foam insulation board perimeter sealed with caulk or polyurethane foam sealant, as shown in Figure 13. This approach, is used by some weatherization contractors. It is generally more labor intensive than SPF application, as it requires cutting of the foam board followed by the application of a caulk or sealant. It can be especially difficult application in tight areas and will require cutting around engineered wood I-joists. Like SPF, this application provides long-lasting insulation, air sealing and moisture control. Note that this method does not always provide sealing of the gap between the sill plate and foundation.

FIGURE 13. Foam board insulation and sealant/caulk at the foundation-framing area
