Moisture Performance of Walls in Energy-Efficient Homes

Recent changes in the minimum energy code (2012/2015 IECC) significantly increased wall insulation levels and reduced wall air leakage targets for light-frame wood walls, relative to the 2006 and 2009 IECC. The long-term moisture performance of these new wall systems is not well understood with regard to vapor drive, condensation risk, and drying capability. With moisture performance increasingly becoming a design consideration in the selection of wall systems, home builders and designers need practical guidance for construction of walls that ensure durability of residential buildings.

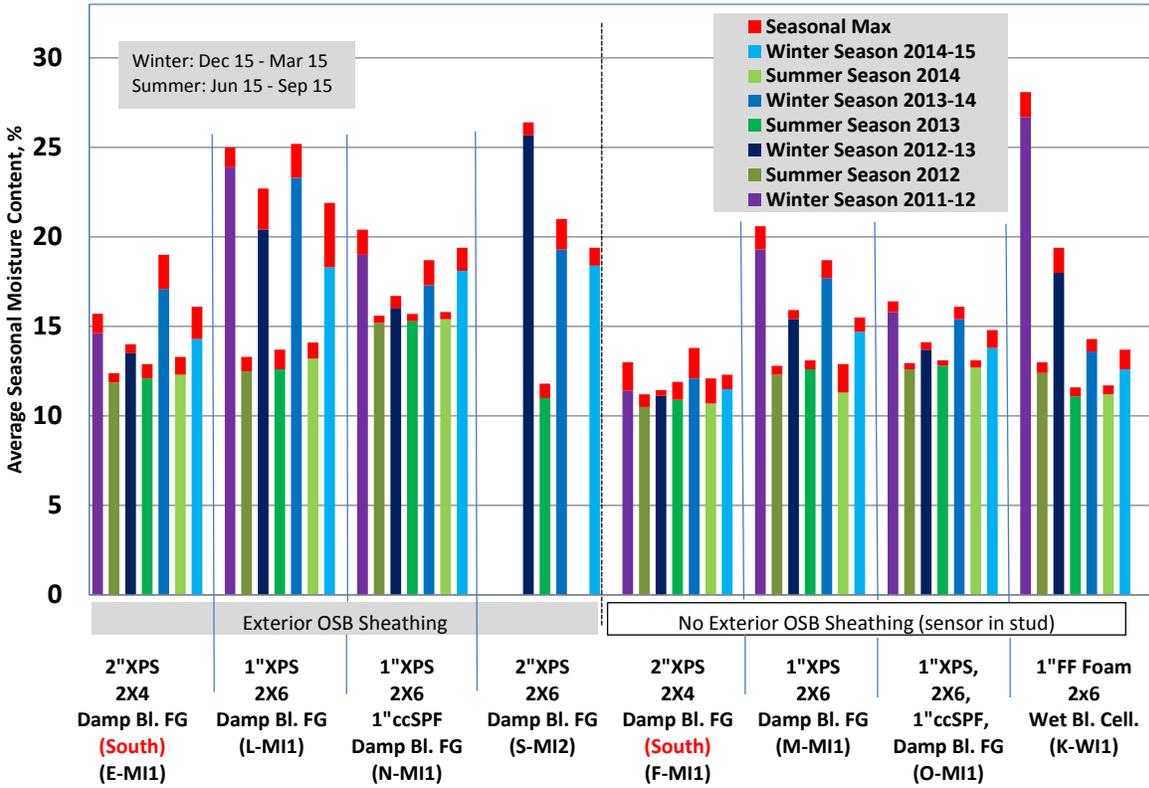
Figure 15. Climate Zone 6A Summary Moisture Content Data

Climate Zone 6A - Moisture Content - North Wall (unless noted otherwise)

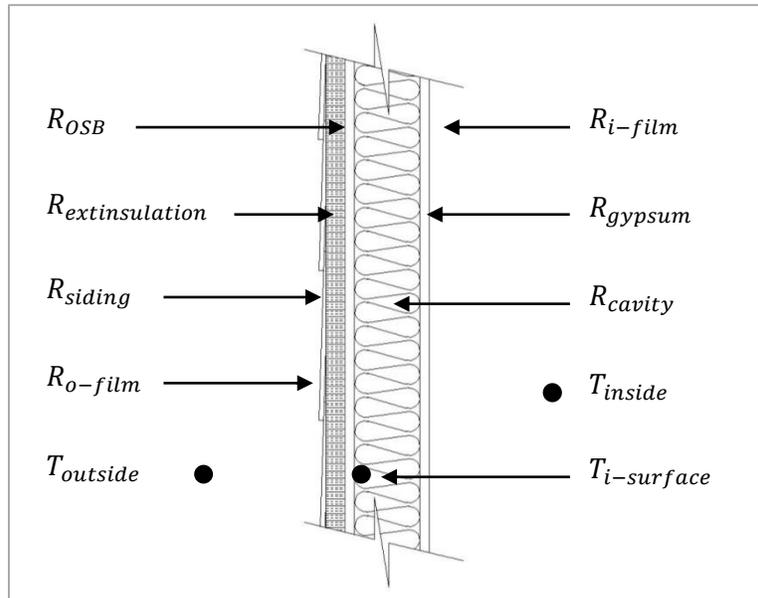
Figure 47. Condensing Surface Calculation Parameters

$T_o \equiv$ outside air temperature
